DEPARTMENT OF TRANSPORTATION

Quality Assurance and Source Inspection

Contract #: 04-0120F4Cty: SF/ALA Rte: 80 PM: 13.2/13.9File #: 69.28**WELDING INSPECTION REPORT****Resident Engineer:** Siegenthaler, Peter**Address:** 333 Burma Road**City:** Oakland, CA 94607**Report No:** WIR-017053**Date Inspected:** 22-Sep-2010**Project Name:** SAS Superstructure**OSM Arrival Time:** 700**Prime Contractor:** American Bridge/Fluor Enterprises, a JV**OSM Departure Time:** 1900**Contractor:** Zhenhua Port Machinery Company, Ltd (ZPMC), Changxing Island **Location:** Shanghai, China**CWI Name:** Yu Dong Ping, Qiu Wen**CWI Present:** Yes No**Inspected CWI report:** Yes No N/A**Rod Oven in Use:** Yes No N/A**Electrode to specification:** Yes No N/A**Weld Procedures Followed:** Yes No N/A**Qualified Welders:** Yes No N/A**Verified Joint Fit-up:** Yes No N/A**Approved Drawings:** Yes No N/A**Approved WPS:** Yes No N/A**Delayed / Cancelled:** Yes No N/A**Bridge No:** 34-0006**Component:** OBG/TOWER**Summary of Items Observed:**

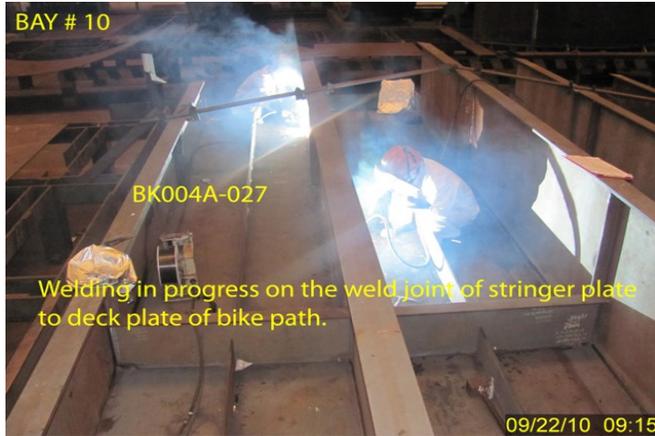
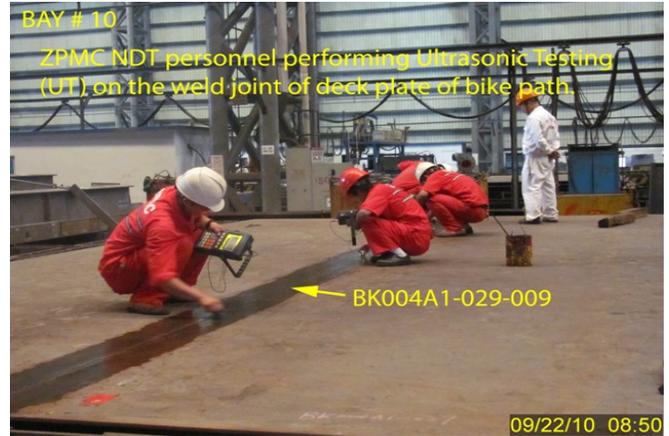
During random in process inspection this QA inspector observed that ZPMC personnel performing heat straightening on the weld joint of deck plate of bike path. The CWI monitoring all the data is identified as Yu Dong Ping. The members are identified as OBG components and the weld designations reviewed are as follows.

During random in process inspection this QA inspector observed that ZPMC NDT personnel performing Ultrasonic Testing (UT) on the weld joint of deck plate of bike path. The members are identified as OBG components and the weld designations reviewed are as follows.
