Quality Assurance and Source Inspection

Contract #: 04-0120F4Cty: SF/ALA Rte: 80 PM: 13.2/13.9File #: 69.28**WELDING INSPECTION REPORT****Resident Engineer:** Siegenthaler, Peter**Address:** 333 Burma Road**City:** Oakland, CA 94607**Report No:** WIR-017063**Date Inspected:** 27-Sep-2010**Project Name:** SAS Superstructure**OSM Arrival Time:** 645**Prime Contractor:** American Bridge/Fluor Enterprises, a JV**OSM Departure Time:** 1845**Contractor:** Zhenhua Port Machinery Company, Ltd (ZPMC), Changxing Island **Location:** Shanghai, China**CWI Name:** Wang Li Yang.**CWI Present:** Yes No**Inspected CWI report:** Yes No N/A**Rod Oven in Use:** Yes No N/A**Electrode to specification:** Yes No N/A**Weld Procedures Followed:** Yes No N/A**Qualified Welders:** Yes No N/A**Verified Joint Fit-up:** Yes No N/A**Approved Drawings:** Yes No N/A**Approved WPS:** Yes No N/A**Delayed / Cancelled:** Yes No N/A**Bridge No:** 34-0006**Component:** Orthotropic Box Girder (OBG)**Summary of Items Observed:**

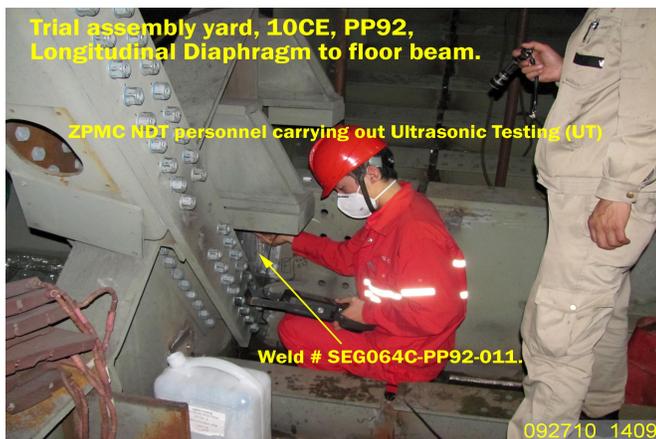
During Random Visual in process Inspection, this QA inspector observed ZPMC NDT personnel carrying out Ultrasonic Testing (UT) on complete penetration joint at 10CE, PP92. Weld joints identified as SEG064C-PP92-011. The attached photographs provide additional detail.
