Quality Assurance and Source Inspection

Contract #: 04-0120F4Cty: SF/ALA Rte: 80 PM: 13.2/13.9File #: 82.28**WELDING INSPECTION REPORT****Resident Engineer:** Siegenthaler, Peter**Address:** 333 Burma Road**City:** Oakland, CA 94607**Report No:** WIR-017074**Date Inspected:** 21-Sep-2010**Project Name:** SAS Superstructure**OSM Arrival Time:** 500**Prime Contractor:** American Bridge/Fluor Enterprises, a JV**OSM Departure Time:** 1330**Contractor:** Westmont Industries**Location:** Santa Fe Springs, CA.**CWI Name:** R. Rodriguez, R. Dominguez**CWI Present:** Yes No**Inspected CWI report:** Yes No N/A**Rod Oven in Use:** Yes No N/A**Electrode to specification:** Yes No N/A**Weld Procedures Followed:** Yes No N/A**Qualified Welders:** Yes No N/A**Verified Joint Fit-up:** Yes No N/A**Approved Drawings:** Yes No N/A**Approved WPS:** Yes No N/A**Delayed / Cancelled:** Yes No N/A**Bridge No:** 34-0006**Component:** Travelers**Summary of Items Observed:**

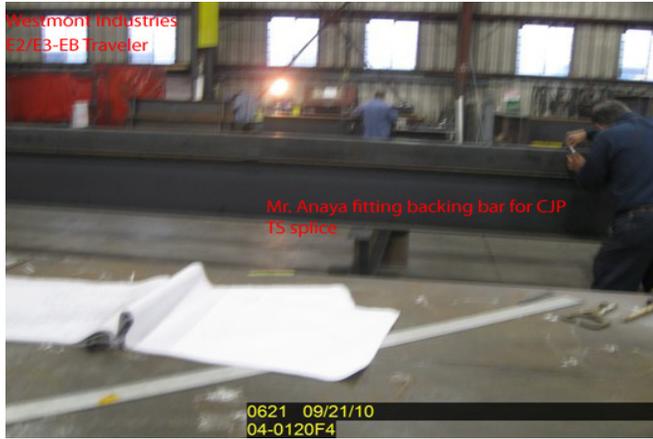
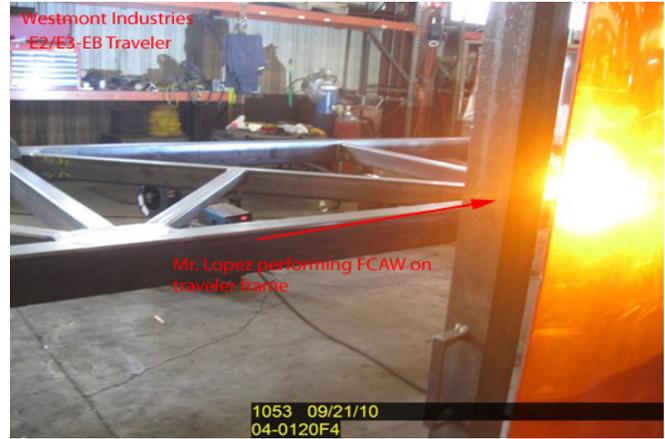
On this date, the QA Inspector observed Westmont Industries (WMI), production welder Alberto Cortes (WID # 3141) performing Flux Core Arc Welding (FCAW) tacking and grinding activities for the Traveler Test Rack. The QA Inspector observed that Mr. Cortes was utilizing a Miller brand machine and wire feeder, to perform the FCAW tacking and that Ultracore 71A85 (.045") diameter wire was being utilized, for the filler metal. The QA Inspector observed that the FCAW Tacking and grinding activities were being performed on the support columns, for the Traveler Test Rack.

On this date, the QA Inspector observed Westmont Industries (WMI), production personnel Larry Swanson and Raymundo Anaya performing Flux Core Arc Welding (FCAW) fitting, tacking and grinding activities for the Traveler Frames. The QA Inspector observed that Mr. Swanson and Mr. Anaya were performing these activities on the backing bars, which will be utilized for the Complete Joint Penetration (CJP) Traveler Frame splices. The QA Inspector observed the above mentioned personnel, cutting and beveling 4 each pieces of backing bar material. After the material was cut and beveled, the QA Inspector observed the pieces of material being placed or fit into the end of the TS material. After the pieces were fit, the QA Inspector then observed Mr. Swanson FCAW tack weld the 4 pieces of material and then remove the tack welded backing bar. The QA Inspector then observed Mr. Swanson FCAW the 4 each ends of the backing bar. After the FCAW was complete, the QA Inspector then observed Mr. Swanson grind flush the 4 each welds and then contour or "round off" the corners of the backing bar. The QA Inspector observed that the grinding continued until the completed backing bar, achieved a tight fit on the interior of the TS end. The QA Inspector observed that the backing bar material being utilized was A572 Gr. 50 and listed in the same group as the base metal, per the applicable Welding Procedure Specification (WPS) requirements.

On this date, the QA Inspector observed Westmont Industries (WMI), production welder Eutimo Lopez (WID # 3035), continuing to perform Flux Core Arc Welding (FCAW) activities on the E2/E3-EB Traveler frames. The QA Inspector observed Mr. Lopez performing the FCAW on previously fit and tack welded Tube Steel (TS) on the Frame Assembly, identified as B235, per the approved shop drawings. The QA Inspector observed that Mr. Lopez was utilizing a Miller brand machine and wire feeder, to perform the FCAW and that Ultracore 71A85 (.045") diameter wire was being utilized, for the filler metal.
