DEPARTMENT OF TRANSPORTATION

Contract #: 04-0120F4Cty: SF/ALA Rte: 80 PM: 13.2/13.9File #: 69.28**WELDING INSPECTION REPORT****Resident Engineer:** Siegenthaler, Peter**Address:** 333 Burma Road**City:** Oakland, CA 94607**Report No:** WIR-017095**Date Inspected:** 26-Aug-2010**Project Name:** SAS Superstructure**OSM Arrival Time:** 700**Prime Contractor:** American Bridge/Fluor Enterprises, a JV**OSM Departure Time:** 1900**Contractor:** Zhenhua Port Machinery Company, Ltd (ZPMC), Changxing Island **Location:** Shanghai, China**CWI Name:** Xu Tao**CWI Present:** Yes No**Inspected CWI report:** Yes No N/A**Rod Oven in Use:** Yes No N/A**Electrode to specification:** Yes No N/A**Weld Procedures Followed:** Yes No N/A**Qualified Welders:** Yes No N/A**Verified Joint Fit-up:** Yes No N/A**Approved Drawings:** Yes No N/A**Approved WPS:** Yes No N/A**Delayed / Cancelled:** Yes No N/A**Bridge No:** 34-0006**Component:** OBG COMPONENT**Summary of Items Observed:**

WELDING INSPECTION REPORT

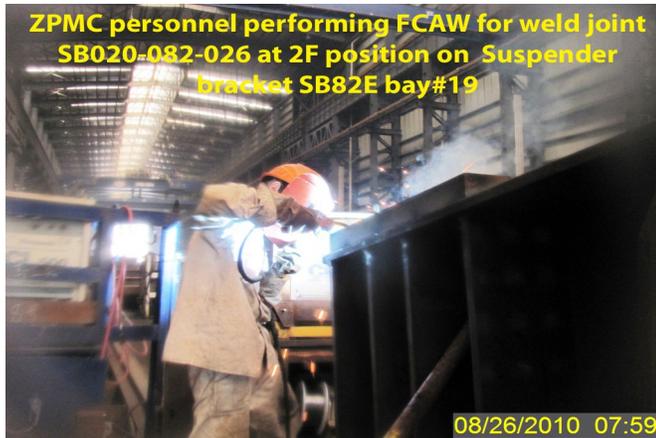
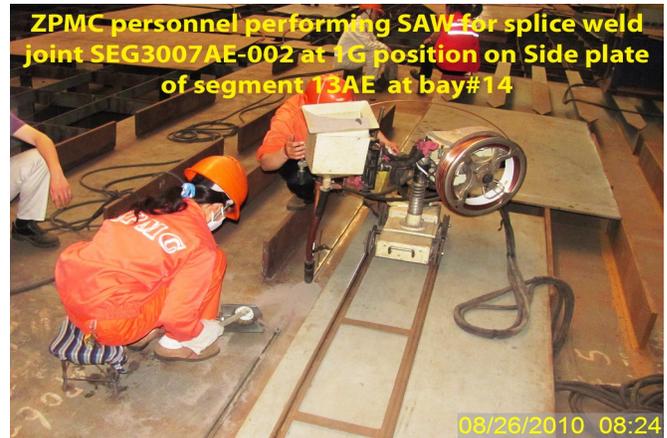
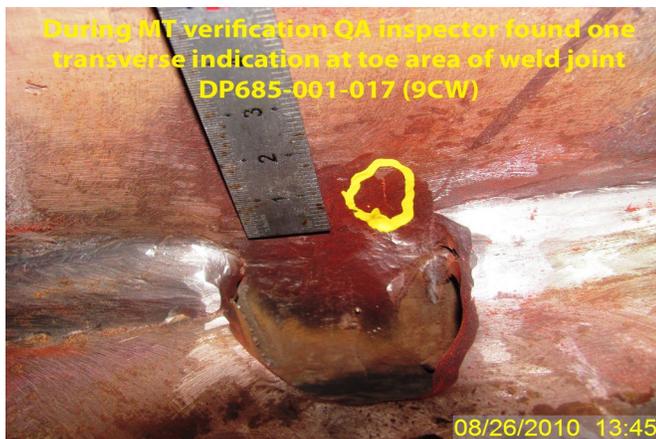
FCAW in the 2F position for the OBG suspender Bracket, weld No. SB020-082-026. The welder is identified as #062806. ZPMC QC is identified as Mr. Xu Tao. The welding variables recorded by QC appear to comply with WPS-B-T-2132.

SAW in the 1G position for the OBG Segment 13AE, weld No. SEG3007AE-002. The welder is identified as #044771. ZPMC QC is identified as Mr. Xing Chen Hui. The welding variables recorded by QC appear to comply with WPS-B-T-2221-B-L2c-S-2.

This Quality Assurance (QA) Inspector performed Visual inspection and verification of Magnetic Particle Testing (MT) 15% for OBG segment 9CW to 9DW hold back area . This QA inspector generated a (MT) report for this date .This area was previously tested and accepted by ZPMC QC MT technicians.

During the Quality Assurance Magnetic Particle Testing (MT) review of welds located on Suspender OBG segment 9CW to 9DW hold back weld , this Quality Assurance (QA) Inspector discovered two (2) Linear indications on the following welds: Weld # SP731-001-031: One(1) Transverse linear indications measuring approximately 8mm in length. Weld # DP685-001-017: One (1) Transverse linear indications measuring approximately 12mm in length. All indications are clearly marked on the material near the weld. OBG Segment 9CW and 9DW are located in trail assembly area .The Notice of Witness Inspection Number (NWIT) is 06488. The indications are located inside an area that has been previously tested by ZPMC Quality Control (QC) personnel.

This Quality Assurance (QA) Inspector performed random visual inspection of OBG segment 11AE internal deck panel U-rib and floor beam surfaces after grit blasting in between panel point PP95 to PP97. Areas that marked for repair were recorded for future repair. Areas requiring additional grinding were marked by QA and repaired by ZPMC personnel.
