**DEPARTMENT OF TRANSPORTATION**

Contract #: 04-0120F4Cty: SF/ALA Rte: 80 PM: 13.2/13.9File #: 69.28**WELDING INSPECTION REPORT****Resident Engineer:** Siegenthaler, Peter**Address:** 333 Burma Road**City:** Oakland, CA 94607**Report No:** WIR-017131**Date Inspected:** 11-Sep-2010**Project Name:** SAS Superstructure**OSM Arrival Time:** 700**Prime Contractor:** American Bridge/Fluor Enterprises, a JV**OSM Departure Time:** 1900**Contractor:** Zhenhua Port Machinery Company, Ltd (ZPMC), Changxing Island **Location:** Shanghai, China**CWI Name:** Wang jie / Geng wei**CWI Present:** Yes No**Inspected CWI report:** Yes No N/A**Rod Oven in Use:** Yes No N/A**Electrode to specification:** Yes No N/A**Weld Procedures Followed:** Yes No N/A**Qualified Welders:** Yes No N/A**Verified Joint Fit-up:** Yes No N/A**Approved Drawings:** Yes No N/A**Approved WPS:** Yes No N/A**Delayed / Cancelled:** Yes No N/A**Bridge No:** 34-0006**Component:** OBG Components**Summary of Items Observed:**

# WELDING INSPECTION REPORT

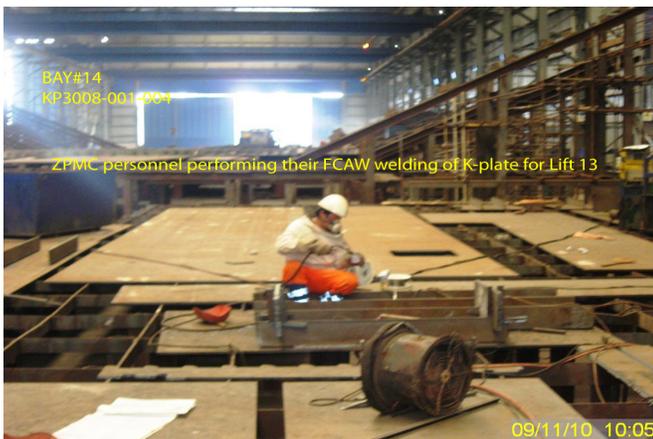
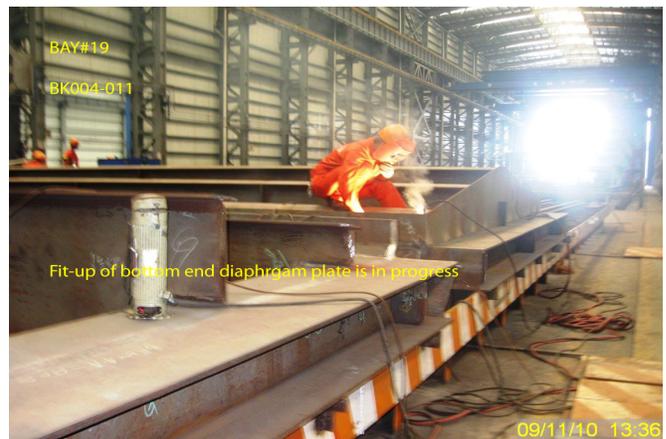
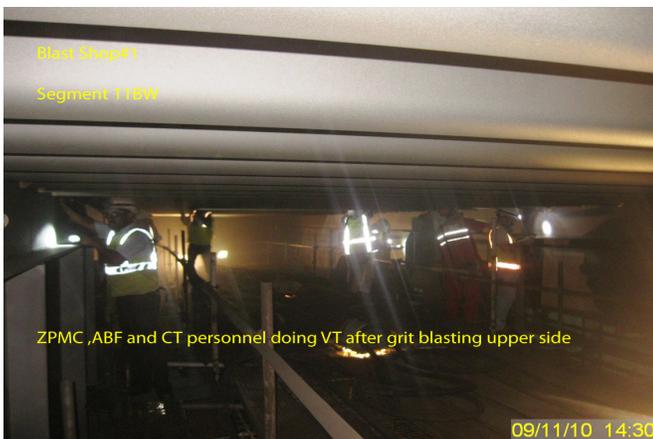
FCAW welding of weld is identified as 2G-008 of K- plate KP3008-001 of segment 13BE. The welder is identified as 067099. ZPMC QC is identified as Mr. Wang xu. The welding variables recorded by QC are appeared to comply with the WPS-B-T-2232-Tc-U4b-F.

FCAW welding of weld is identified as 2G-002 of K-plate KP3005-001 of segment 13AE. The welder is identified as 066236. ZPMC QC is identified as Mr. Wang xu. The welding variables recorded by QC are appeared to comply with the WPS-B-T-2232-Tc-U4b-F.

SAW welding of weld joint 1G-001 (side B) located on PCMK SEG3013AC of Segment 13AW the welder is identified as 045270. ZPMC QC is identified as Mr. Li ming yang. The welding variables recorded by QC appeared to Comply with the WPS-B-T-2221-B-U3c-S-2.

Caltrans Quality Assurance (QA) Inspectors performed random visual inspection of OBG Segment 11BW Interior Upper portion of segment like Floor beam, U-ribs, Deck panel diaphragm and Corner assembly surfaces from the panel point 98 to 100 after grit blasting. Areas that marked for repair were recorded for future repair. Areas requiring additional grinding were marked by QA and repaired by ZPMC personnel.
