DEPARTMENT OF TRANSPORTATION

Contract #: 04-0120F4Cty: SF/ALA Rte: 80 PM: 13.2/13.9File #: 99.28**WELDING INSPECTION REPORT****Resident Engineer:** Siegenthaler, Peter**Address:** 333 Burma Road**City:** Oakland, CA 94607**Report No:** WIR-017157**Date Inspected:** 07-Sep-2010**Project Name:** SAS Superstructure**OSM Arrival Time:** 700**Prime Contractor:** American Bridge/Fluor Enterprises, a JV**OSM Departure Time:** 1900**Contractor:** Zhenhua Port Machinery Company, Ltd (ZPMC) Chanxing Island**Location:** Shanghai, China**CWI Name:** Mr. Xu Tao**CWI Present:** Yes No**Inspected CWI report:** Yes No N/A**Rod Oven in Use:** Yes No N/A**Electrode to specification:** Yes No N/A**Weld Procedures Followed:** Yes No N/A**Qualified Welders:** Yes No N/A**Verified Joint Fit-up:** Yes No N/A**Approved Drawings:** Yes No N/A**Approved WPS:** Yes No N/A**Delayed / Cancelled:** Yes No N/A**Bridge No:** 34-0006**Component:** OBG Segments**Summary of Items Observed:**

WELDING INSPECTION REPORT

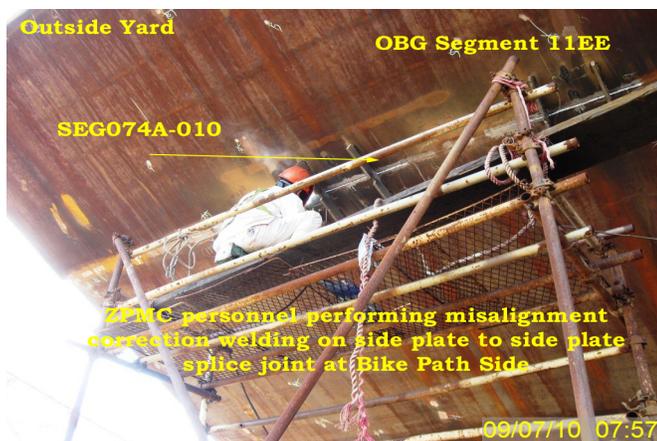
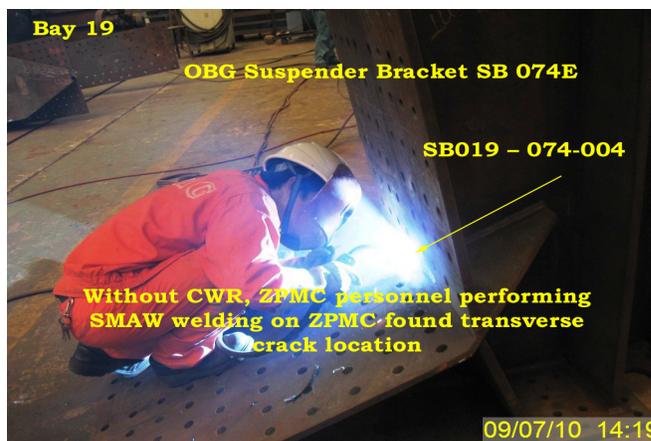
This QA inspector observed ZPMC qualified welding personnel identified as 049339 perform Shielded Metal Arc Welding (SMAW) welding on side plate misalignment location of OBG Segment 11EE, repair weld joint identified as SEG074A-010. ZPMC QC is identified as Mr. Wu Shi gao. The welding parameters as measured using QC's calibrated instruments appeared to be in general compliance with WPS-345-SMAW-4G (4F)-FCM-Repair, which is used as per Critical Welding Repair Report (CWR) B-WR1862.

This QA inspector observed ZPMC qualified welding personnel identified as 062806 perform Flux Core Arc Welding (FCAW) welding on OBG Bike path, weld joint identified as BK004A5-004-090. ZPMC QC is identified as Mr. Li Ming Yang. The welding parameters as measured using QC's calibrated instruments appeared to be in general compliance with WPS-B-T-2231-Tc-U4b-F.

Incident Description: During random Quality Assurance visual review of the Suspender bracket components, this Quality Assurance Inspector (QA) observed that ZPMC personnel performing weld repair of one (1) Transverse Indication measuring approximately 10 mm without the prior approval of the Engineer or an approved CWR. This weld is rejected 3rd (third) time by Ultrasonic Testing NDT method. The transverse indication found in the excavation after removing the weld by carbon arc gouging. The weld is identified as SB019-074-004. The weld is Complete Joint Penetration (CJP) weld joining Edge plate to Bottom Plate. This member is located inside the OBG Fabrication shop Bay-19
