DEPARTMENT OF TRANSPORTATION

Contract #: 04-0120F4Cty: SF/ALA Rte: 80 PM: 13.2/13.9File #: 69.28**WELDING INSPECTION REPORT****Resident Engineer:** Siegenthaler, Peter**Address:** 333 Burma Road**City:** Oakland, CA 94607**Report No:** WIR-017199**Date Inspected:** 12-Sep-2010**Project Name:** SAS Superstructure**OSM Arrival Time:** 700**Prime Contractor:** American Bridge/Fluor Enterprises, a JV**OSM Departure Time:** 1900**Contractor:** Zhenhua Port Machinery Company, Ltd (ZPMC), Changxing Island **Location:** Shanghai, China**CWI Name:** Mr. Qiu wen/Xu Le Feng**CWI Present:** Yes No**Inspected CWI report:** Yes No N/A**Rod Oven in Use:** Yes No N/A**Electrode to specification:** Yes No N/A**Weld Procedures Followed:** Yes No N/A**Qualified Welders:** Yes No N/A**Verified Joint Fit-up:** Yes No N/A**Approved Drawings:** Yes No N/A**Approved WPS:** Yes No N/A**Delayed / Cancelled:** Yes No N/A**Bridge No:** 34-0006**Component:** Tower**Summary of Items Observed:**

WELDING INSPECTION REPORT

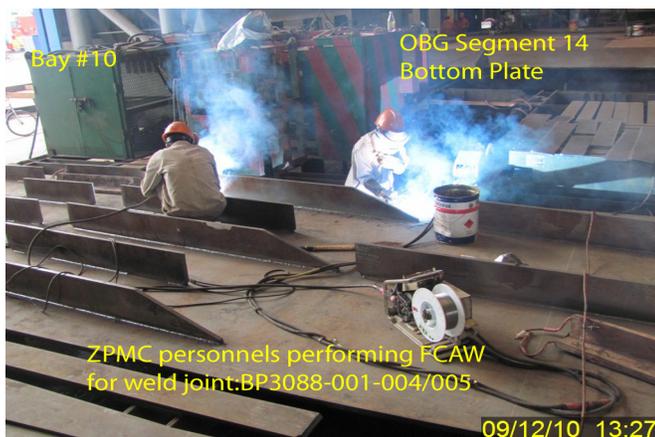
FCAW in the 2F position for the OBG Segment Bottom Plate, weld No: BP3088-001-004/005. The welders are identified as #052075/044473. ZPMC QC is identified as Mr. Sun Tian Liang. The welding variables recorded by QC appear to comply with WPS-B-T-2132. Please see the attached picture.

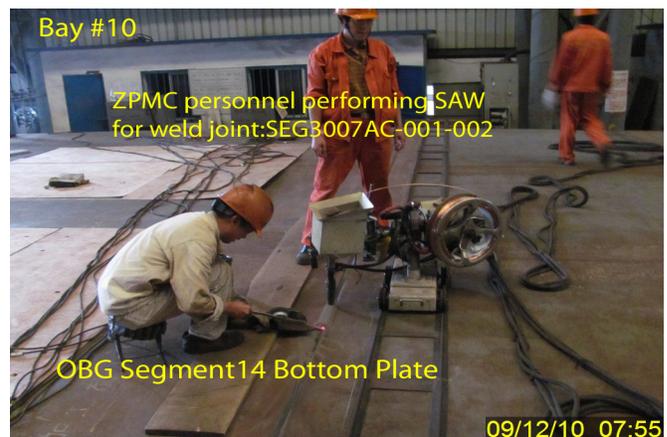
SAW in the 1G position for the OBG Segment 14 Bottom Plate, weld No: SEG3007AC-001-002. The welder is identified as #058100. ZPMC QC is identified as Mr. Zhang Lin. The welding variables recorded by QC appear to comply with WPS-B-T-2221-B-U3C-S-2. Please see the attached picture.
