**DEPARTMENT OF TRANSPORTATION**

Contract #: 04-0120F4Cty: SF/ALA Rte: 80 PM: 13.2/13.9File #: 82.28**WELDING INSPECTION REPORT****Resident Engineer:** Siegenthaler, Peter**Address:** 333 Burma Road**City:** Oakland, CA 94607**Report No:** WIR-017224**Date Inspected:** 24-Sep-2010**Project Name:** SAS Superstructure**OSM Arrival Time:** 500**Prime Contractor:** American Bridge/Fluor Enterprises, a JV**OSM Departure Time:** 1330**Contractor:** Westmont Industries**Location:** Santa Fe Springs, CA.**CWI Name:** R. Rodriguez, R. Dominguez**CWI Present:** Yes No**Inspected CWI report:** Yes No N/A**Rod Oven in Use:** Yes No N/A**Electrode to specification:** Yes No N/A**Weld Procedures Followed:** Yes No N/A**Qualified Welders:** Yes No N/A**Verified Joint Fit-up:** Yes No N/A**Approved Drawings:** Yes No N/A**Approved WPS:** Yes No N/A**Delayed / Cancelled:** Yes No N/A**Bridge No:** 34-0006**Component:** Travelers**Summary of Items Observed:**

## WELDING INSPECTION REPORT

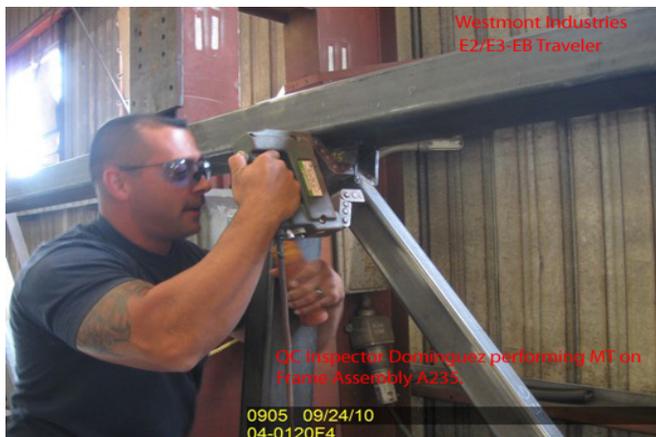
On this Date, the QA Inspector observed Smith Emery QC Inspector Ruben Dominguez performing Magnetic Particle Testing (MT) on the previously completed fillet and Flare Groove welds. The QA Inspector observed that the testing was being performed on the E2/E3-EB Traveler Frame Assembly, identified as A235.

The QA Inspector was later informed by QC Inspector Dominguez that no rejectable indications were found after testing and that an applicable Magnetic Testing report will be completed, per the contract requirements.

The QA Inspector observed that the above mentioned testing appeared to be in compliance with the contract requirements.

See attached picture below.
