Contract #: 04-0120F4Cty: SF/ALA Rte: 80 PM: 13.2/13.9File #: 82.28**WELDING INSPECTION REPORT****Resident Engineer:** Siegenthaler, Peter**Address:** 333 Burma Road**City:** Oakland, CA 94607**Report No:** WIR-017292**Date Inspected:** 30-Sep-2010**Project Name:** SAS Superstructure**Prime Contractor:** American Bridge/Fluor Enterprises, a JV**Contractor:** Westmont Industries**OSM Arrival Time:** 500**OSM Departure Time:** 1330**Location:** Santa Fe Springs, CA.**CWI Name:** R. Rodriguez, R. Dominguez**CWI Present:** Yes No**Inspected CWI report:** Yes No N/A**Rod Oven in Use:** Yes No N/A**Electrode to specification:** Yes No N/A**Weld Procedures Followed:** Yes No N/A**Qualified Welders:** Yes No N/A**Verified Joint Fit-up:** Yes No N/A**Approved Drawings:** Yes No N/A**Approved WPS:** Yes No N/A**Delayed / Cancelled:** Yes No N/A**Bridge No:** 34-0006**Component:** Travelers**Summary of Items Observed:**

Traveler Test Rack

E2/E3-EB Traveler

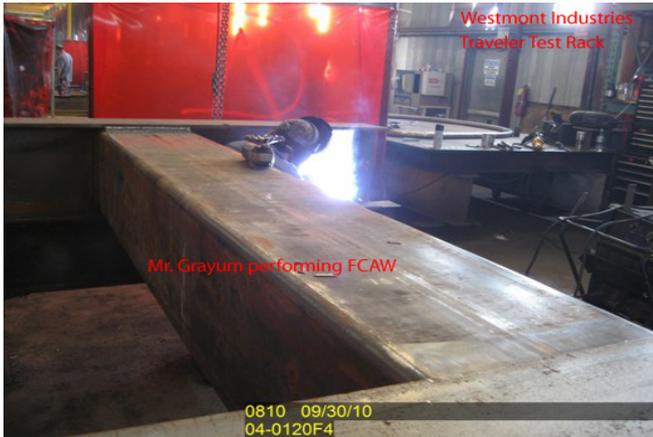
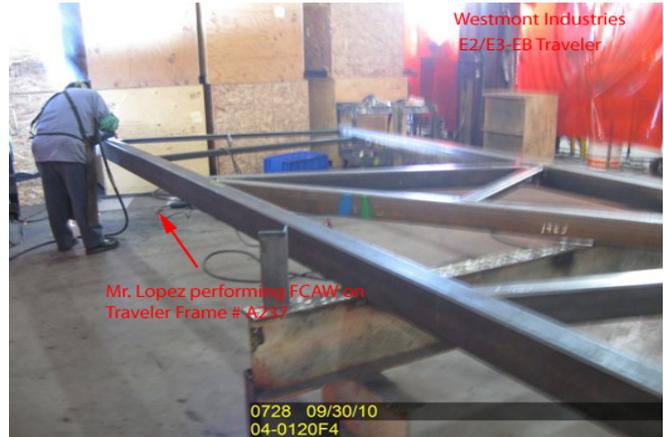
On this date, the QA Inspector observed Westmont Industries (WMI), production welder Eutimo Lopez (WID # 3035), continuing to perform Flux Core Arc Welding (FCAW) activities for the E2/E3-EB Traveler frames. The QA Inspector observed Mr. Lopez performing the FCAW on previously fit and tack welded Tube Steel (TS) on the Frame Assembly, identified as A237, per the shop drawings. The QA Inspector observed that Mr. Lopez was utilizing a Miller brand machine and wire feeder, to perform the FCAW and that Ultracore 71A85 (.045") diameter wire was being utilized, for the filler metal.

On this date, the QA Inspector observed Westmont Industries (WMI), production personnel Larry Swanson, continuing to perform Flux Core Arc Welding (FCAW) fitting, tacking and grinding activities for the E2/E3-EB Traveler Frames. The QA Inspector observed that Mr. Swanson was fitting the previously cut to length Tube Steel (TS) diagonal bracing, for the Frame assembly identified as A240. The QA Inspector observed Mr. Swanson utilizing various sizes of C-Clamps, to fit the diagonal bracing and once the diagonal bracing was fit, the QA Inspector randomly observed Mr. Swanson performing dimensional measurements, utilizing a steel tape measure. The QA Inspector then observed Mr. Swanson reference the approved shop drawings, located nearby the fabrication area, to verify the dimensions of the fit diagonal bracing. After the measurements were checked and verified, the QA Inspector then observed Mr. Swanson FCAW tack weld the diagonal bracing. After the tack welding was complete, the QA Inspector observed that Mr. Swanson would then perform minor grinding activities on the completed tacks, to smooth and blend.

On this date, the QA Inspector observed Westmont Industries (WMI), production welder Raymundo Anaya, continuing to perform Flux Core Arc Welding (FCAW) tacking and fitting activities, for the Traveler Frames. The QA Inspector observed that Mr. Anaya was performing the FCAW on square Tube Steel (TS) and plate material, for the Traveler Frame Assembly 61 identified as A245, reference shop drawing WMI-SAS-245. The QA Inspector observed that Mr. Anaya was utilizing a Miller brand machine and wire feeder, to perform the FCAW tacking activities and that Ultracore 71A85 (.045") diameter wire was being utilized, for the filler metal. The QA Inspector observed that Mr. Anaya was being assisted by WMI production fitter Cesar Canales and the applicable Welding procedure specifications (WPS's) were nearby the work area.
