**DEPARTMENT OF TRANSPORTATION**

Contract #: 04-0120F4Cty: SF/ALA Rte: 80 PM: 13.2/13.9File #: 1.28**WELDING INSPECTION REPORT****Resident Engineer:** Siegenthaler, Peter**Address:** 333 Burma Road**City:** Oakland, CA 94607**Report No:** WIR-017355**Date Inspected:** 07-Oct-2010**Project Name:** SAS Superstructure**OSM Arrival Time:** 700**Prime Contractor:** American Bridge/Fluor Enterprises, a JV**OSM Departure Time:** 1530**Contractor:** American Bridge/Fluor Enterprises, a JV**Location:** Jobsite**CWI Name:** See below**CWI Present:** Yes No**Inspected CWI report:** Yes No N/A**Rod Oven in Use:** Yes No N/A**Electrode to specification:** Yes No N/A**Weld Procedures Followed:** Yes No N/A**Qualified Welders:** Yes No N/A**Verified Joint Fit-up:** Yes No N/A**Approved Drawings:** Yes No N/A**Approved WPS:** Yes No N/A**Delayed / Cancelled:** Yes No N/A**Bridge No:** 34-0006**Component:** SAS OBG**Summary of Items Observed:**

## WELDING INSPECTION REPORT

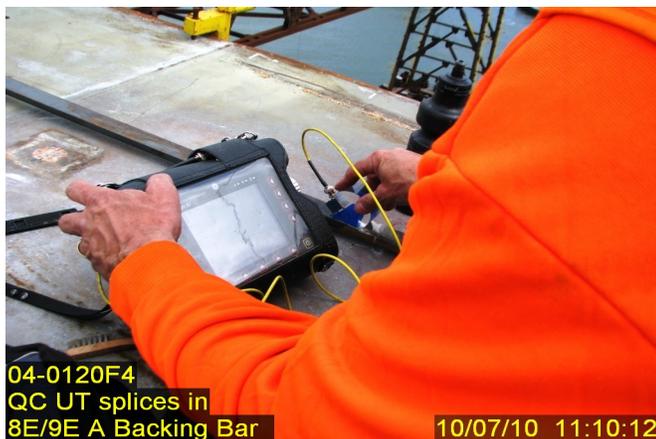
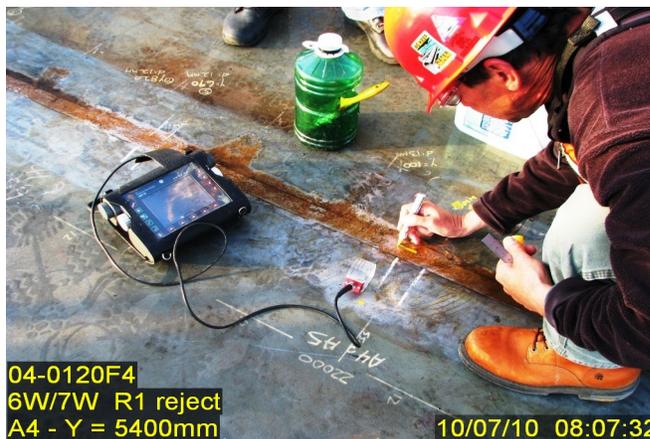
The QAI periodically observed QC Inspector Tom Pasqualone performing Ultrasonic Testing (UT) of weld R-1 & R-2 Repairs in OBG Field Splice 6W/7W weld ID: A1 through A5. Mr. Pasqualone utilized the UT Procedure identified as SE-UT-D1.5-CT-100 Rev.4 during the examination of the splice weld repair areas. The QC technician performed the required shear wave testing during the testing for weld soundness utilizing a .63 x .75 rectangular transducer. The work at this location was completed during this shift and the QAI observed that work appeared to be in general compliance with the contract documents. The QAI observed that Mr. Pasqualone had marked (3) three UT rejectable indications (see photo below) in the following R-1 repair locations:

Weld A1 - Y = 5090, Length = 35mm and Depth = 12mm.

Weld A3 - Y = 3600, Length = 35mm and Depth = 9mm.

Weld A4 - Y = 5400, Length = 40mm and Depth = 11mm.
