DEPARTMENT OF TRANSPORTATION

Quality Assurance and Source Inspection

Contract #: 04-0120F4Cty: SF/ALA Rte: 80 PM: 13.2/13.9File #: 69.28**WELDING INSPECTION REPORT****Resident Engineer:** Siegenthaler, Peter**Address:** 333 Burma Road**City:** Oakland, CA 94607**Report No:** WIR-017376**Date Inspected:** 29-Sep-2010**Project Name:** SAS Superstructure**OSM Arrival Time:** 700**Prime Contractor:** American Bridge/Fluor Enterprises, a JV**OSM Departure Time:** 1900**Contractor:** Zhenhua Port Machinery Company, Ltd (ZPMC), Changxing Island **Location:** Shanghai, China**CWI Name:** Xu tao**CWI Present:** Yes No**Inspected CWI report:** Yes No N/A**Rod Oven in Use:** Yes No N/A**Electrode to specification:** Yes No N/A**Weld Procedures Followed:** Yes No N/A**Qualified Welders:** Yes No N/A**Verified Joint Fit-up:** Yes No N/A**Approved Drawings:** Yes No N/A**Approved WPS:** Yes No N/A**Delayed / Cancelled:** Yes No N/A**Bridge No:** 34-0006**Component:** OBG Components**Summary of Items Observed:**

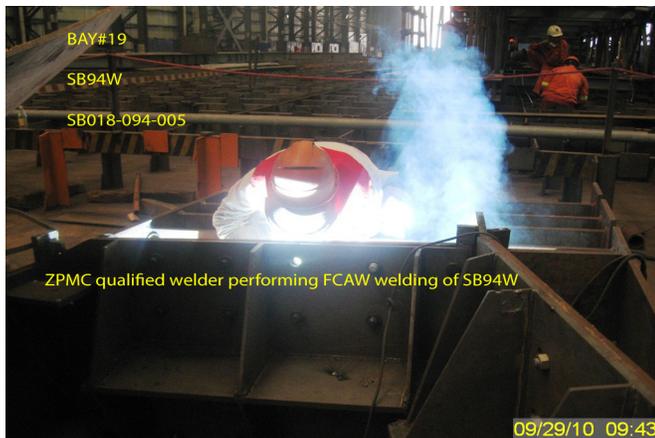
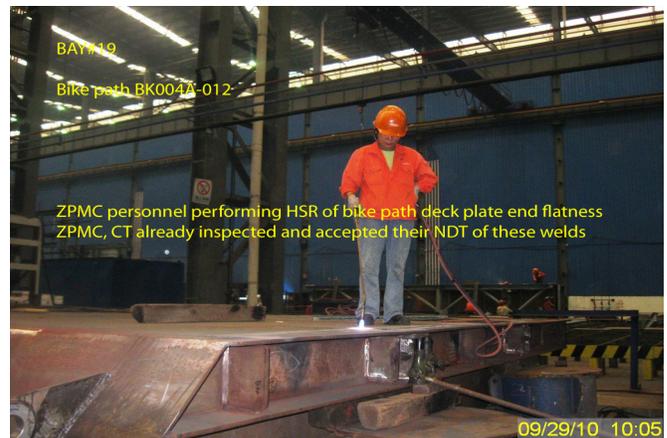
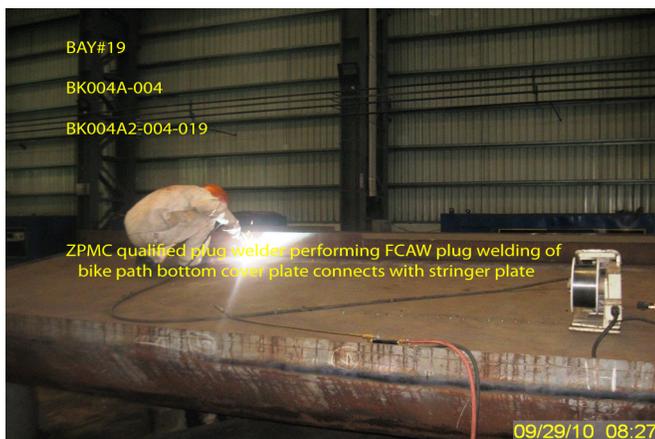
FCAW welding of weld is identified as 2G-031 of SB018-092 for SB92W. The welder is identified as 062739. ABF QC is identified as Mr. Peng wen jun. The welding variables recorded by QC are appeared to comply with the WPS-B-T-2232-Tc-U4b-F.

FCAW welding of weld is identified as 2G-043 of SB021-092 for SB92E. The welder is identified as 062755. ABF QC is identified as Mr. Peng wen jun. The welding variables recorded by QC are appeared to comply with the WPS-B-T-2232-Tc-U4b-F.

FCAW welding of weld is identified as 1G-005 of SB018-094 for SB94W. The welder is identified as 062808. ABF QC is identified as Mr. Peng wen jun. The welding variables recorded by QC are appeared to comply with the WPS-B-T-2231-Tc-U4b-F.

FCAW welding of weld is identified as 1G-001 of SB021-094 for SB94E. The welder is identified as 58792. ABF QC is identified as Mr. Peng wen jun. The welding variables recorded by QC are appeared to comply with the WPS-B-T-2231-Tc-U4b-F.

FCAW welding of weld is identified as 3F-110 of BK005A5-001 for BK005A-001. The welder is identified as 062786. ZPMC QC is identified as Mr. Guo xing hui. The welding variables recorded by QC are appeared to comply with the WPS-B-T-2133.

FCAW welding of plug weld is identified as 1G-019 of BK004A2-004 for BK004A-004. The welder is identified as 259902. ZPMC QC is identified as Mr. Xu tao. The welding variables recorded by QC are appeared to comply with the WPS-B-T-2132-Plug-1.

ZPMC personnel performing HSR of bike path BK004A-002 deck plate ends after ZPMC and CT NDT completed and accepted satisfactorily. But ZPMC has internal report to perform this HSR
The report is identified as HSR1(B)-9311 dated on 09.09.2010.
