Contract #: 04-0120F4Cty: SF/ALA Rte: 80 PM: 13.2/13.9File #: 69.28**WELDING INSPECTION REPORT****Resident Engineer:** Siegenthaler, Peter**Address:** 333 Burma Road**City:** Oakland, CA 94607**Report No:** WIR-017439**Date Inspected:** 26-Sep-2010**Project Name:** SAS Superstructure**OSM Arrival Time:** 700**Prime Contractor:** American Bridge/Fluor Enterprises, a JV**OSM Departure Time:** 1900**Contractor:** Zhenhua Port Machinery Company, Ltd (ZPMC), Changxing Island **Location:** Shanghai, China**CWI Name:** Mr. Xu Le Fung.**CWI Present:** Yes No**Inspected CWI report:** Yes No N/A**Rod Oven in Use:** Yes No N/A**Electrode to specification:** Yes No N/A**Weld Procedures Followed:** Yes No N/A**Qualified Welders:** Yes No N/A**Verified Joint Fit-up:** Yes No N/A**Approved Drawings:** Yes No N/A**Approved WPS:** Yes No N/A**Delayed / Cancelled:** Yes No N/A**Bridge No:** 34-0006**Component:** Tower and Orthotropic Box Girder (OBG)**Summary of Items Observed:**

On this day CALTRANS OSM Quality Assurance (QA) Inspector Shailesh Gaikwad was present during the times noted above for observations relative to the fabrication of the SAS Superstructure being performed by Zhenhua Port Mac

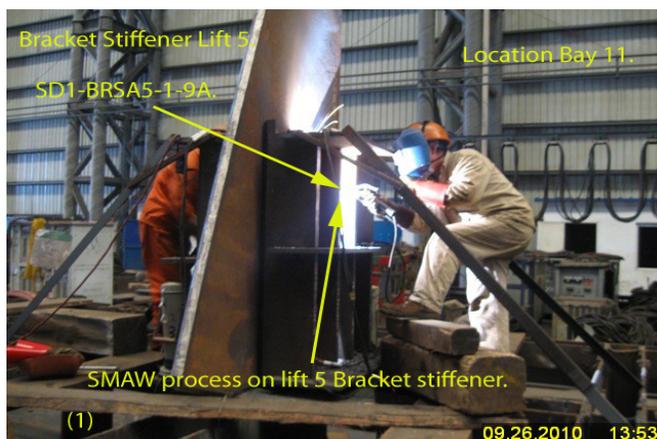
This QA Inspector observed ZPMC qualified welding personnel identified as 046769, 041271, Perform Shielded Metal Arc Welding (SMAW) on Lift 5 bracket stiffener. Joint identified as SD1-BRSA5-1-13A, 9A. ZPMC CWI Identified as Yu Dong Ping. The welding parameters as measured using QC's calibrated instrument appeared to be in general compliance with WPS-B-T-3213-Tc-U4b. For more information see below attached picture number 1.

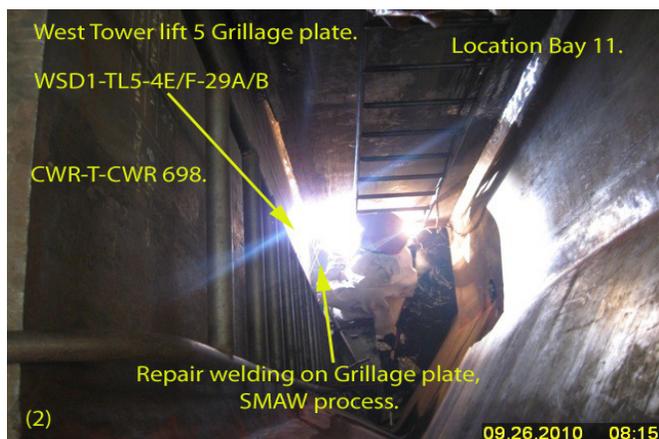
This QA Inspector observed ZPMC qualified welding personnel identified as 037996 Perform Shielded Metal Arc Welding (SMAW) on West Tower lift 5 Grillage plate. Joint identified as WSD1-TL5-4E/F-29A/B. ZPMC QC Identified as Zhao Mao Mao with Critical welding repair report CWR-T-CWR698. The welding parameters as measured using QC's calibrated instrument appeared to be in general compliance with WPS-485-SMAW-3G (3F) Repair. For more information see below attached picture number 2.
