Quality Assurance and Source Inspection

Contract #: 04-0120F4Cty: SF/ALA Rte: 80 PM: 13.2/13.9File #: 1.28**WELDING INSPECTION REPORT****Resident Engineer:** Siegenthaler, Peter**Address:** 333 Burma Road**City:** Oakland, CA 94607**Report No:** WIR-017449**Date Inspected:** 15-Oct-2010**Project Name:** SAS Superstructure**OSM Arrival Time:** 700**Prime Contractor:** American Bridge/Fluor Enterprises, a JV**OSM Departure Time:** 1530**Contractor:** American Bridge/Fluor Enterprises, a JV**Location:** Jobsite**CWI Name:** See below**CWI Present:** Yes No**Inspected CWI report:** Yes No N/A**Rod Oven in Use:** Yes No N/A**Electrode to specification:** Yes No N/A**Weld Procedures Followed:** Yes No N/A**Qualified Welders:** Yes No N/A**Verified Joint Fit-up:** Yes No N/A**Approved Drawings:** Yes No N/A**Approved WPS:** Yes No N/A**Delayed / Cancelled:** Yes No N/A**Bridge No:** 34-0006**Component:** SAS OBG**Summary of Items Observed:**

WELDING INSPECTION REPORT

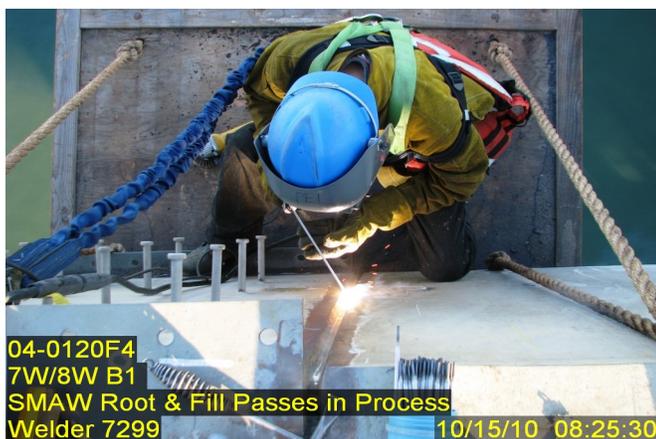
The QAI periodically observed the in process welding root and fill passes at OBG Field Splice 7W/8W weld ID: B1, from the A face per the SMAW process in the 3G (vertical) position by AB/F approved welder Jin Pei Wang (ID 7299). QC Inspector Tony Sherwood was present to monitor the progress and verify that the welding parameters were within the limits established by the approved welding Procedure Specification (WPS) identified as ABF-WPS-D1.5-1040B. The work at this location was in process for the duration of the QA Inspector's shift and appeared to be in general compliance with the contract documents. See photo below.

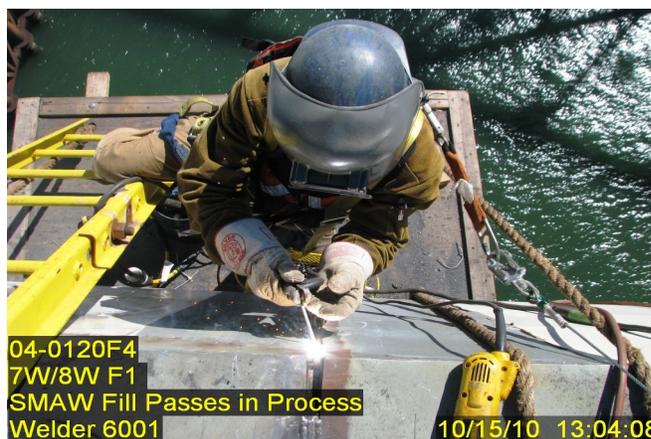
The QAI periodically observed the in process welding fill passes at OBG Field Splice 7W/8W weld ID: F1, from the A face per the SMAW process in the 3G (vertical) position by AB/F approved welder James Zhen (ID 6001). QC Inspector Tony Sherwood was present to monitor the progress and verify that the welding parameters were within the limits established by the approved welding Procedure Specification (WPS) identified as ABF-WPS-D1.5-1040B. The work at this location was in process for the duration of the QA Inspector's shift and appeared to be in general compliance with the contract documents. See photo below.
