DEPARTMENT OF TRANSPORTATION

Quality Assurance and Source Inspection

Contract #: 04-0120F4Cty: SF/ALA Rte: 80 PM: 13.2/13.9File #: 69.28**WELDING INSPECTION REPORT****Resident Engineer:** Siegenthaler, Peter**Address:** 333 Burma Road**City:** Oakland, CA 94607**Report No:** WIR-017505**Date Inspected:** 30-Sep-2010**Project Name:** SAS Superstructure**OSM Arrival Time:** 700**Prime Contractor:** American Bridge/Fluor Enterprises, a JV**OSM Departure Time:** 1900**Contractor:** Zhenhua Port Machinery Company, Ltd (ZPMC), Changxing Island **Location:** Shanghai, China**CWI Name:** Mr. Xu Le Fung.**CWI Present:** Yes No**Inspected CWI report:** Yes No N/A**Rod Oven in Use:** Yes No N/A**Electrode to specification:** Yes No N/A**Weld Procedures Followed:** Yes No N/A**Qualified Welders:** Yes No N/A**Verified Joint Fit-up:** Yes No N/A**Approved Drawings:** Yes No N/A**Approved WPS:** Yes No N/A**Delayed / Cancelled:** Yes No N/A**Bridge No:** 34-0006**Component:** Tower and Orthotropic Box Girder (OBG)**Summary of Items Observed:**

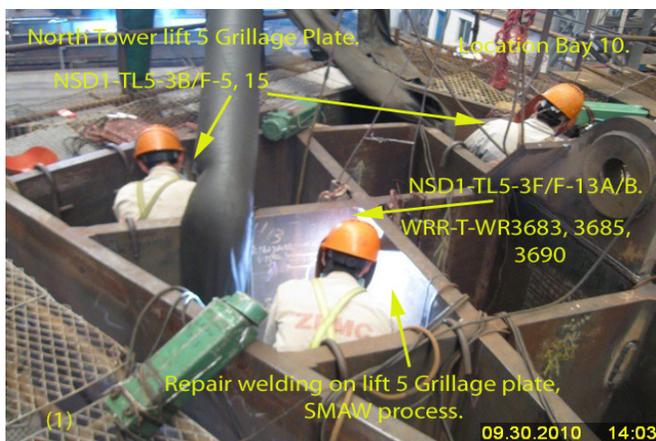
This QA Inspector observed ZPMC qualified welding personnel identified as 040582, 052930 Perform Shielded Metal Arc Welding (SMAW) on North Tower lift 5 Grillage plate. Joint identified as NSD1-TL5-3B/F-5, 15. ZPMC QC Identified as Yu Zhi Lai with Temporary welding repair report WRR-T-WR3683, 3685. The welding parameters as measured using QC's calibrated instrument appeared to be in general compliance with WPS-485-SMAW-3G (3F) Repair. For more information see below attached picture number 1.
