Contract #: 04-0120F4Cty: SF/ALA Rte: 80 PM: 13.2/13.9File #: 99.28**WELDING INSPECTION REPORT****Resident Engineer:** Siegenthaler, Peter**Address:** 333 Burma Road**City:** Oakland, CA 94607**Report No:** WIR-017596**Date Inspected:** 25-Oct-2010**Project Name:** SAS Superstructure**OSM Arrival Time:** 700**Prime Contractor:** American Bridge/Fluor Enterprises, a JV**OSM Departure Time:** 1900**Contractor:** Zhenhua Port Machinery Company, Ltd (ZPMC)**Location:** Shanghai, China

Orthotropic Box Girder (OBG) at Trial Assembly Areas

WELDING INSPECTION REPORT

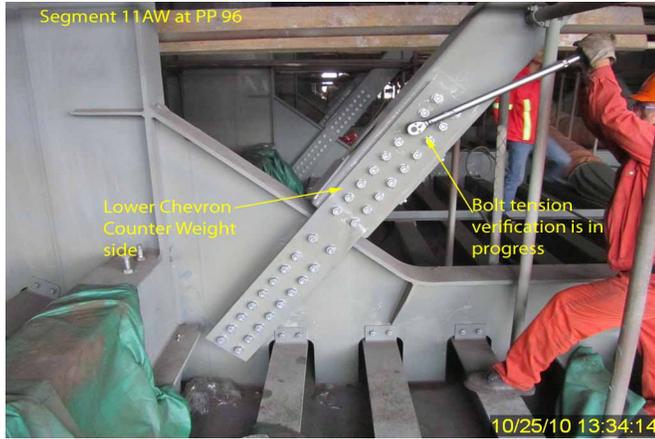
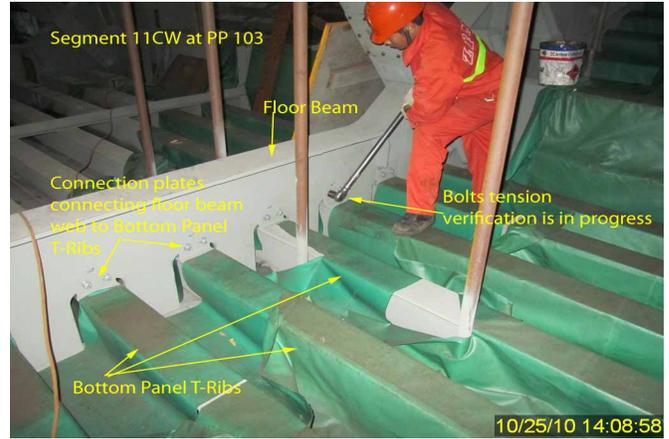
This Quality Assurance (QA) Inspector witnessed final bolt tension verification for Lower Chevron, X3D Bracket, H-Beam to Floor Beam and Upper Chevron at Panel Point (PP) 95, PP 96 and PP 97 for Segment 11AW at Counter Weight side and Cross Beam side. Inspected 10% on a random basis and found the tension to be in general compliance. Inspection was performed against the Notification No. 00523 Dated October 25, 2010.

The Manual Torque wrench used was Serial No. XO2-676. Please reference the pictures attached for more comprehensive details.
