**DEPARTMENT OF TRANSPORTATION**

Contract #: 04-0120F4Cty: SF/ALA Rte: 80 PM: 13.2/13.9File #: 69.28**WELDING INSPECTION REPORT****Resident Engineer:** Siegenthaler, Peter**Address:** 333 Burma Road**City:** Oakland, CA 94607**Report No:** WIR-017608**Date Inspected:** 27-Oct-2010**Project Name:** SAS Superstructure**OSM Arrival Time:** 700**Prime Contractor:** American Bridge/Fluor Enterprises, a JV**OSM Departure Time:** 1900**Contractor:** Zhenhua Port Machinery Company, Ltd (ZPMC), Changxing Island **Location:** Shanghai, China**CWI Name:** Xu Tao**CWI Present:** Yes No**Inspected CWI report:** Yes No N/A**Rod Oven in Use:** Yes No N/A**Electrode to specification:** Yes No N/A**Weld Procedures Followed:** Yes No N/A**Qualified Welders:** Yes No N/A**Verified Joint Fit-up:** Yes No N/A**Approved Drawings:** Yes No N/A**Approved WPS:** Yes No N/A**Delayed / Cancelled:** Yes No N/A**Bridge No:** 34-0006**Component:** OBG**Summary of Items Observed:**

## WELDING INSPECTION REPORT

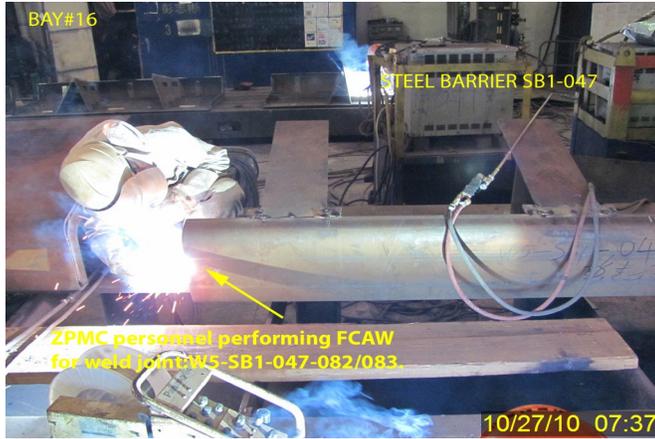
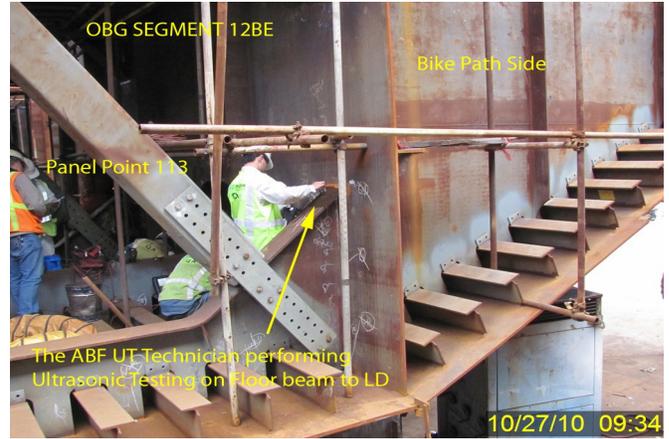
FCAW in the 2F position for the OBG Segment Steel Barrier, The weld joint was designated as: W5-SB1-047-082/083. The welder is identified as #066751. ZPMC QC is identified as Mr. Gu Pan. The welding variables recorded by QC appear to comply with WPS-B-T-2132. Please see the attached picture.
