Quality Assurance and Source Inspection

Contract #: 04-0120F4Cty: SF/ALA Rte: 80 PM: 13.2/13.9File #: 1.28**WELDING INSPECTION REPORT****Resident Engineer:** Siegenthaler, Peter**Address:** 333 Burma Road**City:** Oakland, CA 94607**Report No:** WIR-017610**Date Inspected:** 21-Oct-2010**Project Name:** SAS Superstructure**OSM Arrival Time:** 630**Prime Contractor:** American Bridge/Fluor Enterprises, a JV**OSM Departure Time:** 1500**Contractor:** American Bridge/Fluor Enterprises, a JV**Location:** Jobsite**CWI Name:** See below**CWI Present:** Yes No**Inspected CWI report:** Yes No N/A**Rod Oven in Use:** Yes No N/A**Electrode to specification:** Yes No N/A**Weld Procedures Followed:** Yes No N/A**Qualified Welders:** Yes No N/A**Verified Joint Fit-up:** Yes No N/A**Approved Drawings:** Yes No N/A**Approved WPS:** Yes No N/A**Delayed / Cancelled:** Yes No N/A**Bridge No:** 34-0006**Component:** SAS OBG**Summary of Items Observed:**

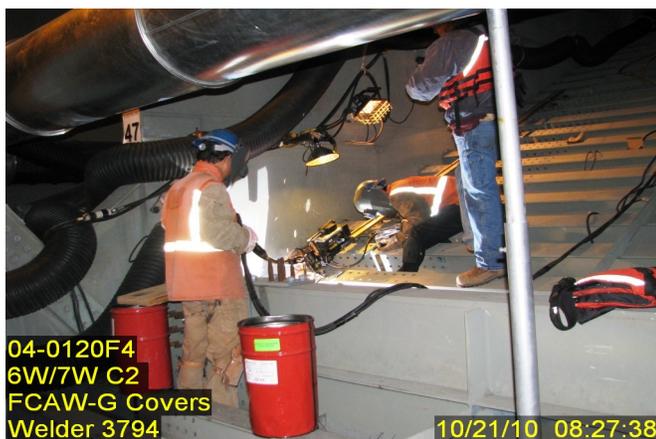
The QAI periodically observed AB/F approved welder Song Tao Huang (ID 3794) assisted by AB/F approved welder Jin Quan Huang, performing welding per the Flux Cored Arc Welding (FCAW-G) process in the 3G (vertical) position of cover passes on weld ID: C2. See photo below. The QAI observed QC Inspector Tony Sherwood was present to monitor the progress and verify that the welding parameters were within the limits established by the approved Welding Procedure Specification (WPS) identified as ABF-WPS-D1.5-3042B-1. The QAI observed as Mr. Sherwood measured the welding parameters and noted the following measurements were obtained: amps = 250, volts = 23.5 and travel speed=333. The QAI calculated the heat input as 1.05 kJ/mm. The QAI observed that the work at this location was in process and appeared to be in general compliance with contract documents.

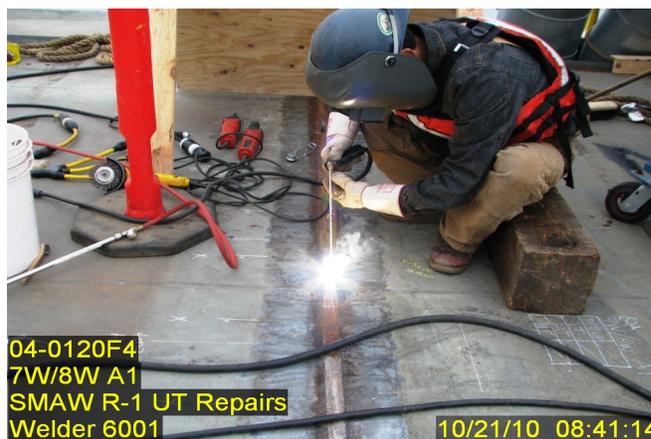
The QAI periodically observed AB/F approved welder Jin Pei Wang (ID 7299) performing grinding to excavate R-1 Ultrasonic Testing (UT) repair areas identified by UT performed by QC on 10-20-10 on OBG Field Splice 7W/8W Weld ID: A1. The QAI periodically observed QC Inspector Steve McConnell performing Magnetic Particle Testing (MT) of the excavated areas prior to welding. Once the excavated areas were determined to be deep enough and free of indications the final dimensions were measured by the QC as noted below. The QAI observed that the performance and evaluation of the MT appeared to comply with the MT procedure identified as SE-MT-CT-D1.5-101 Rev. 4. The QAI also periodically observed AB/F approved welder James Zhen (ID 6001) performing welding per the Shielded Metal Arc Welding (SMAW) process in the 1G (flat) position. See photo below. QC Inspector Steve McConnell was present to monitor the progress and verify that the welding parameters were within the limits established by the approved welding Procedure Specification (WPS) identified as ABF-WPS-D1.5-1001 Repair. The areas excavated during the QA Inspectors shift were verified by the QAI, and were located at the following Y locations and had the following dimensions:

- 1) Y = 0mm, Length = 265mm Width = 27mm and Depth = 20mm,
- 2) Y = 1000mm, Length = 470mm Width = 20mm and Depth = 20mm
- 3) Y = 2400mm, Length = 160mm Width = 20mm and Depth = 14mm
- 4) Y = 3570mm, Length = 125mm Width = 20mm and Depth = 14mm
