Contract #: 04-0120F4Cty: SF/ALA Rte: 80 PM: 13.2/13.9File #: 69.28**WELDING INSPECTION REPORT****Resident Engineer:** Siegenthaler, Peter**Address:** 333 Burma Road**City:** Oakland, CA 94607**Report No:** WIR-017646**Date Inspected:** 28-Oct-2010**Project Name:** SAS Superstructure**OSM Arrival Time:** 1900**Prime Contractor:** American Bridge/Fluor Enterprises, a JV**OSM Departure Time:** 700**Contractor:** Zhenhua Port Machinery Company, Ltd (ZPMC), Changxing Island **Location:** Shanghai, China**CWI Name:** See Below**CWI Present:** Yes No**Inspected CWI report:** Yes No N/A**Rod Oven in Use:** Yes No N/A**Electrode to specification:** Yes No N/A**Weld Procedures Followed:** Yes No N/A**Qualified Welders:** Yes No N/A**Verified Joint Fit-up:** Yes No N/A**Approved Drawings:** Yes No N/A**Approved WPS:** Yes No N/A**Delayed / Cancelled:** Yes No N/A**Bridge No:** 34-0006**Component:** OBG**Summary of Items Observed:**

OBG Bay 14

WELDING INSPECTION REPORT

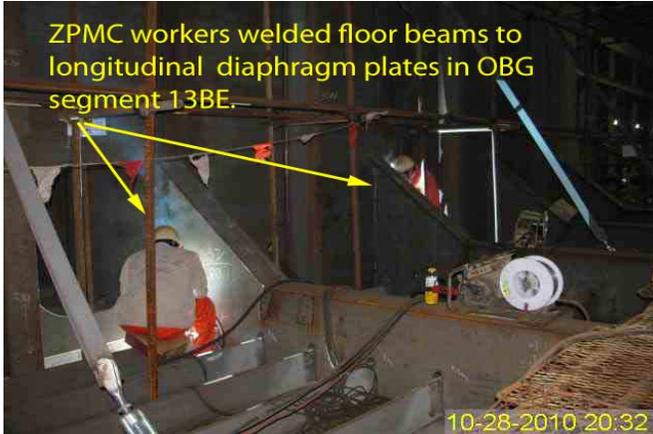
This QA Inspector observed ZPMC welder Mr. Tian Zhaoquan, stencil 045246 used shielded metal arc welding procedure WPS-B-P-2113-FCM-1 to make OBG segment 13CW weld SEG3015D-022. This weld joins floor beam FB3231-001 to longitudinal diaphragm LD3036 near panel point PP124.0. This QA Inspector measured a welding current of approximately 160 amps. Mr. Tian Zhaoquan appeared to be certified to make this weld and the base materials appeared to have been preheated with an acetylene torch prior to welding. Items observed on this date appeared to generally comply with applicable contract documents.
