DEPARTMENT OF TRANSPORTATION

Contract #: 04-0120F4Cty: SF/ALA Rte: 80 PM: 13.2/13.9File #: 69.28**WELDING INSPECTION REPORT****Resident Engineer:** Siegenthaler, Peter**Address:** 333 Burma Road**City:** Oakland, CA 94607**Report No:** WIR-017647**Date Inspected:** 29-Oct-2010**Project Name:** SAS Superstructure**OSM Arrival Time:** 1900**Prime Contractor:** American Bridge/Fluor Enterprises, a JV**OSM Departure Time:** 700**Contractor:** Zhenhua Port Machinery Company, Ltd (ZPMC), Changxing Island **Location:** Shanghai, China**CWI Name:** See Below**CWI Present:** Yes No**Inspected CWI report:** Yes No N/A**Rod Oven in Use:** Yes No N/A**Electrode to specification:** Yes No N/A**Weld Procedures Followed:** Yes No N/A**Qualified Welders:** Yes No N/A**Verified Joint Fit-up:** Yes No N/A**Approved Drawings:** Yes No N/A**Approved WPS:** Yes No N/A**Delayed / Cancelled:** Yes No N/A**Bridge No:** 34-0006**Component:** OBG**Summary of Items Observed:**

WELDING INSPECTION REPORT

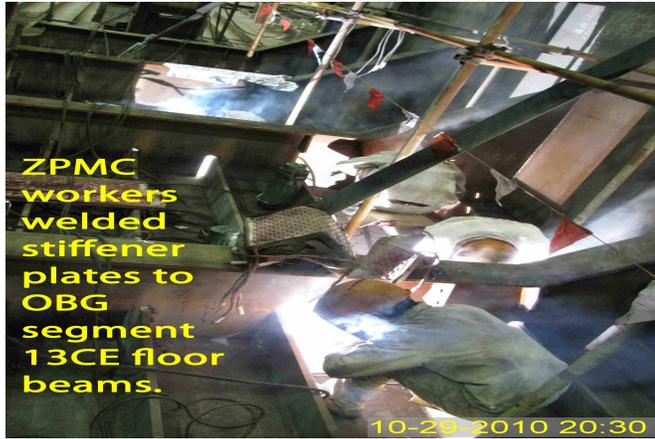
This QA Inspector observed ZPMC welder Mr. Bian Henggui stencil 051359 used shielded metal arc welding process to make OBG segment 13BE tack welds on deck plate 3188-001 between PL3184A and PL3184B. This QA Inspector observed the base material did not appear to have been preheated prior to welding. This QA Inspector informed ZPMC CWI Mr. Lv Li Qing that the workers did not appear to have a torch in the area where the welding was taking place and the base materials had not been preheated prior to welding. Mr. Lv Li Qing informed this QA Inspector that the tack welds will be ground out and that the workers will use a torch to preheat the base material prior to making any additional tack welds. This QA Inspector asked ZPMC CWI Mr. Lv Li Qing the identification of this weld joint and after he looked at the available drawings, he informed this QA Inspector that he was not able to determine this weld number. This QA Inspector observed the welding electrodes were stored in a portable rod oven which was warm to the touch. Items observed on this date do not fully appear to comply with applicable contract documents.
