DEPARTMENT OF TRANSPORTATION

Quality Assurance and Source Inspection

Contract #: 04-0120F4Cty: SF/ALA Rte: 80 PM: 13.2/13.9File #: 69.28**WELDING INSPECTION REPORT****Resident Engineer:** Siegenthaler, Peter**Address:** 333 Burma Road**City:** Oakland, CA 94607**Report No:** WIR-017658**Date Inspected:** 31-Oct-2010**Project Name:** SAS Superstructure**OSM Arrival Time:** 700**Prime Contractor:** American Bridge/Fluor Enterprises, a JV**OSM Departure Time:** 1900**Contractor:** Zhenhua Port Machinery Company, Ltd (ZPMC), Changxing Island **Location:** Shanghai, China**CWI Name:** Li Yang**CWI Present:** Yes No**Inspected CWI report:** Yes No N/A**Rod Oven in Use:** Yes No N/A**Electrode to specification:** Yes No N/A**Weld Procedures Followed:** Yes No N/A**Qualified Welders:** Yes No N/A**Verified Joint Fit-up:** Yes No N/A**Approved Drawings:** Yes No N/A**Approved WPS:** Yes No N/A**Delayed / Cancelled:** Yes No N/A**Bridge No:** 34-0006**Component:** OBG Segment**Summary of Items Observed:**

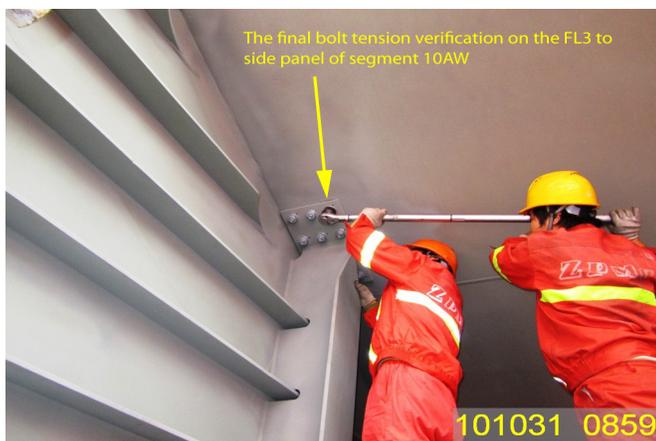
This QA inspector witnessed the final bolt tension verification on the FL3 to bottom panel of segment 10AW. The torque wrench S/N was XO2-666. The QA inspector witnessed 10% of the bolts on a random basis and found the tensioning of the bolts appeared to be in general compliance with the contract specifications. The panel point and bolt size designations were as follows:

For additional information please reference the pictures below:
