Quality Assurance and Source Inspection

Contract #: 04-0120F4Cty: SF/ALA Rte: 80 PM: 13.2/13.9File #: 69.28**WELDING INSPECTION REPORT****Resident Engineer:** Siegenthaler, Peter**Address:** 333 Burma Road**City:** Oakland, CA 94607**Report No:** WIR-017704**Date Inspected:** 02-Nov-2010**Project Name:** SAS Superstructure**OSM Arrival Time:** 645**Prime Contractor:** American Bridge/Fluor Enterprises, a JV**OSM Departure Time:** 1845**Contractor:** Zhenhua Port Machinery Company, Ltd (ZPMC), Changxing Island **Location:** Shanghai, China**CWI Name:** Liu Hua Jie.**CWI Present:** Yes No**Inspected CWI report:** Yes No N/A**Rod Oven in Use:** Yes No N/A**Electrode to specification:** Yes No N/A**Weld Procedures Followed:** Yes No N/A**Qualified Welders:** Yes No N/A**Verified Joint Fit-up:** Yes No N/A**Approved Drawings:** Yes No N/A**Approved WPS:** Yes No N/A**Delayed / Cancelled:** Yes No N/A**Bridge No:** 34-0006**Component:** Orthotropic Box Girder (OBG)**Summary of Items Observed:**

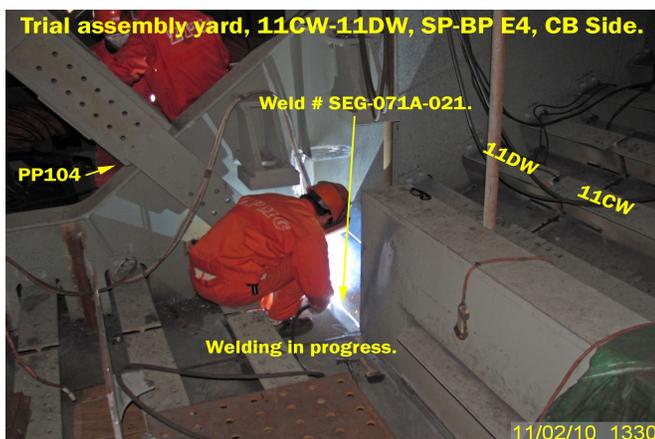
FCAW welding of weld joint SEG069A-012, SEG071A-021; located at Trial assembly yard. Welder is identified as 040609; ZPMC Quality Control Inspector (QC) is identified as Zhu Zhong Hai. The welding variables recorded by Quality Control Inspector (QC) appeared to comply with the Applicable WPS: WPS-B-T-2231-TC-U4B-F. The attached photographs provide additional detail.
