DEPARTMENT OF TRANSPORTATION

Contract #: 04-0120F4Cty: SF/ALA Rte: 80 PM: 13.2/13.9File #: 99.28**WELDING INSPECTION REPORT****Resident Engineer:** Siegenthaler, Peter**Address:** 333 Burma Road**City:** Oakland, CA 94607**Report No:** WIR-017836**Date Inspected:** 06-Nov-2010**Project Name:** SAS Superstructure**OSM Arrival Time:** 700**Prime Contractor:** American Bridge/Fluor Enterprises, a JV**OSM Departure Time:** 1900**Contractor:** Zhenhua Port Machinery Company, Ltd (ZPMC)**Location:** Shanghai, China**CWI Name:** Li Yang and Zhu Zhong Hai**CWI Present:** Yes No**Inspected CWI report:** Yes No N/A**Rod Oven in Use:** Yes No N/A**Electrode to specification:** Yes No N/A**Weld Procedures Followed:** Yes No N/A**Qualified Welders:** Yes No N/A**Verified Joint Fit-up:** Yes No N/A**Approved Drawings:** Yes No N/A**Approved WPS:** Yes No N/A**Delayed / Cancelled:** Yes No N/A**Bridge No:** 34-0006**Component:** OBG Trial Assembly**Summary of Items Observed:**

Orthotropic Box Girder (OBG) at Trial Assembly Areas

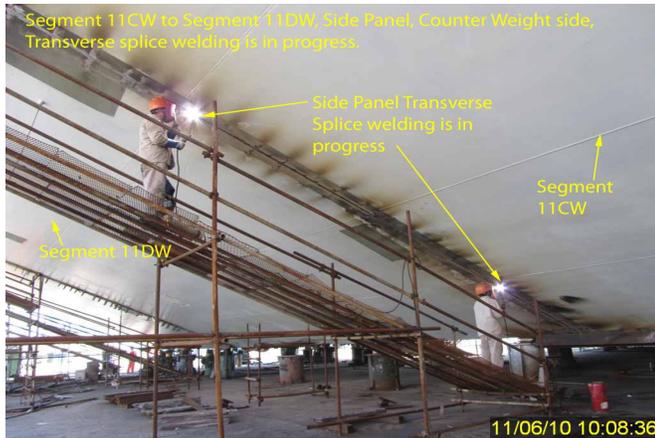
Segment 11CW to Segment 11DW

This QA Inspector observed the in-process welding by Shielded Metal Arc Welding (SMAW) process on a Complete Joint Penetration (CJP) groove weld. The Weld joint was designated as OBW11C-002. The welder identification was 046709 and 044551 and observed welding in the 4G (Overhead) position using approved Welding Procedure Specification WPS-B-P-2214-B-U2-FCM-1. The piece mark was identified as the Side Panel, transverse splice Counter Weight side.

Please reference the pictures attached for more comprehensive details.
