DEPARTMENT OF TRANSPORTATION

Contract #: 04-0120F4Cty: SF/ALA Rte: 80 PM: 13.2/13.9File #: 69.28**WELDING INSPECTION REPORT****Resident Engineer:** Siegenthaler, Peter**Address:** 333 Burma Road**City:** Oakland, CA 94607**Report No:** WIR-017880**Date Inspected:** 08-Nov-2010**Project Name:** SAS Superstructure**OSM Arrival Time:** 645**Prime Contractor:** American Bridge/Fluor Enterprises, a JV**OSM Departure Time:** 1845**Contractor:** Zhenhua Port Machinery Company, Ltd (ZPMC), Changxing Island **Location:** Shanghai, China**CWI Name:** An Qing Xiang.**CWI Present:** Yes No**Inspected CWI report:** Yes No N/A**Rod Oven in Use:** Yes No N/A**Electrode to specification:** Yes No N/A**Weld Procedures Followed:** Yes No N/A**Qualified Welders:** Yes No N/A**Verified Joint Fit-up:** Yes No N/A**Approved Drawings:** Yes No N/A**Approved WPS:** Yes No N/A**Delayed / Cancelled:** Yes No N/A**Bridge No:** 34-0006**Component:** Orthotropic Box Girder (OBG)**Summary of Items Observed:**

WELDING INSPECTION REPORT

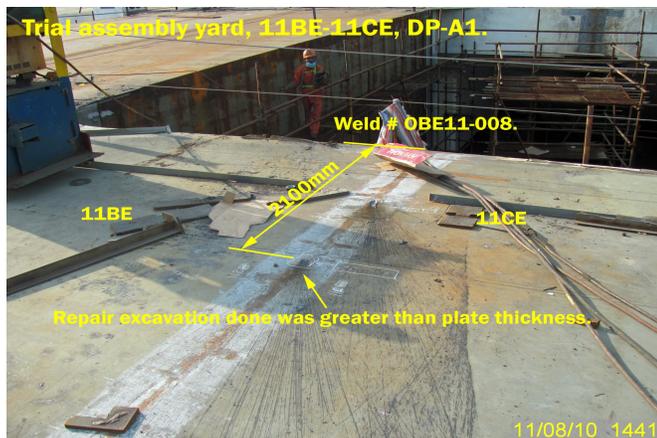
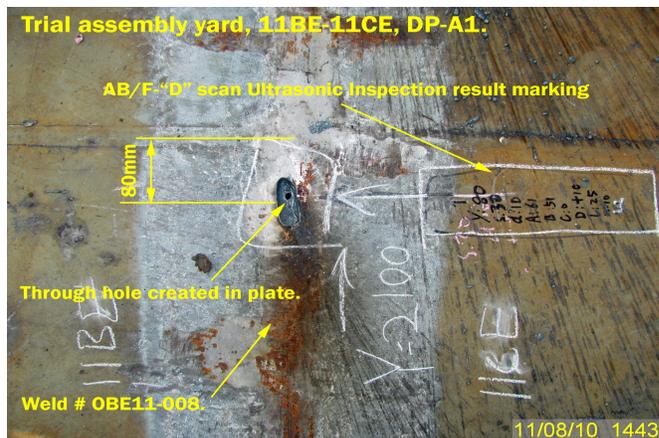
During Random Visual in process Inspection, this QA inspector observed repair excavation done on Transverse splice of Deck panels at intersection of OBG segment 11BE-11CE. The weld is identified as OBE11-008 (DP-A1). This excavation was done according to AB/F-“D” scan Ultrasonic Inspection Report “UT-11E-040”. This QA inspector observed excavation done was greater than plate thickness, which resulted creating a through hole in excavated area. Excavation is located at 80mm from the start of the weld on cross beam side.

ZPMC Quality Control Inspector (QC) identified as “An Qing Xiang”. ZPMC agreed to submit Critical Weld Repair Report (CWR) for above mentioned location. The attached photographs provide additional detail.
