**DEPARTMENT OF TRANSPORTATION**

Contract #: 04-0120F4Cty: SF/ALA Rte: 80 PM: 13.2/13.9File #: 99.28**WELDING INSPECTION REPORT****Resident Engineer:** Siegenthaler, Peter**Address:** 333 Burma Road**City:** Oakland, CA 94607**Report No:** WIR-018126**Date Inspected:** 14-Nov-2010**Project Name:** SAS Superstructure**OSM Arrival Time:** 700**Prime Contractor:** American Bridge/Fluor Enterprises, a JV**OSM Departure Time:** 1900**Contractor:** Zhenhua Port Machinery Company, Ltd (ZPMC)**Location:** Shanghai, China

Orthotropic Box Girder (OBG) at Trial Assembly Areas

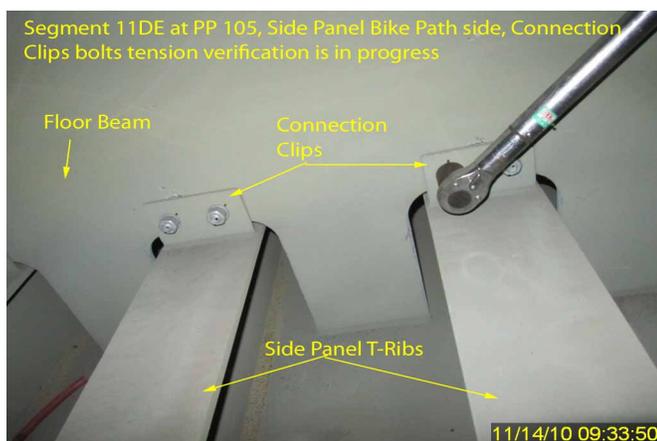
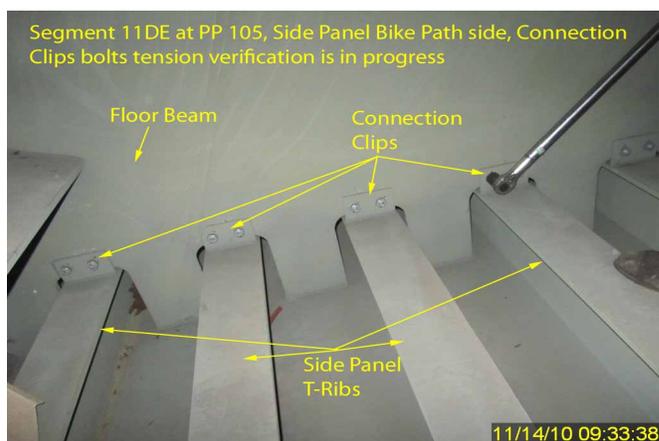
This QA Inspector witnessed the final bolt tension verification on bolts connecting the T-Rib connections plates at Side Panel (Cross Beam and Bike Path side) and at Bottom Panel at the Panel Points (PP) 101, PP 102 and PP 103 for Segment 11CE. The QA Inspector verified the bolt tension on a random basis and the results appeared to be in general compliance. The Inspection was performed against Notification No. 00551 dated November 14, 2010.

Note: ZPMC QC did not offer inspection, for the 1st Connection clip (reference of numbering taken from the work point E4 towards work point E6) at PP 103, as no bolts are installed due to mis-match hole.

Note: ZPMC QC did not offer inspection, for the 2nd Connection clip (reference of numbering taken from the work point E3 towards work point E1) at PP 107 and PP 108 as no bolts are installed due to mis-match hole.
