Contract #: 04-0120F4Cty: SF/ALA Rte: 80 PM: 13.2/13.9File #: 69.28**WELDING INSPECTION REPORT****Resident Engineer:** Siegenthaler, Peter**Address:** 333 Burma Road**City:** Oakland, CA 94607**Report No:** WIR-018254**Date Inspected:** 19-Nov-2010**Project Name:** SAS Superstructure**OSM Arrival Time:** 700**Prime Contractor:** American Bridge/Fluor Enterprises, a JV**OSM Departure Time:** 1900**Contractor:** Zhenhua Port Machinery Company, Ltd (ZPMC), Changxing Island **Location:** Shanghai, China**CWI Name:** Li Yang**CWI Present:** Yes No**Inspected CWI report:** Yes No N/A**Rod Oven in Use:** Yes No N/A**Electrode to specification:** Yes No N/A**Weld Procedures Followed:** Yes No N/A**Qualified Welders:** Yes No N/A**Verified Joint Fit-up:** Yes No N/A**Approved Drawings:** Yes No N/A**Approved WPS:** Yes No N/A**Delayed / Cancelled:** Yes No N/A**Bridge No:** 34-0006**Component:** OBG Segment**Summary of Items Observed:**

OBG # TRIAL ASSEMBLY YARD (11AE)

WELDING INSPECTION REPORT

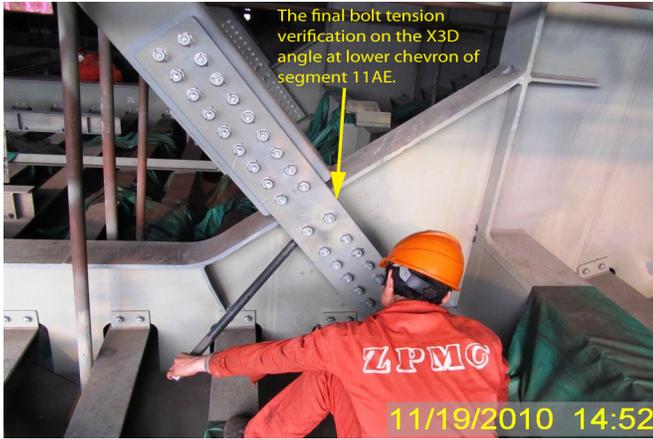
This QA Inspector witnessed the final bolt tension verification on the X3D angle at lower chevron of segment 11AE. The torque wrench S/N was XO2-114. The QA inspector witnessed 10% of the bolts on a random basis and found the tensioning of the bolts appeared to be in general compliance with the contract specifications. The panel point and bolt size designations were as follows:

For additional information please reference the pictures below:
