DEPARTMENT OF TRANSPORTATION

Contract #: 04-0120F4Cty: SF/ALA Rte: 80 PM: 13.2/13.9File #: 69.28**WELDING INSPECTION REPORT****Resident Engineer:** Siegenthaler, Peter**Address:** 333 Burma Road**City:** Oakland, CA 94607**Report No:** WIR-018258**Date Inspected:** 20-Nov-2010**Project Name:** SAS Superstructure**OSM Arrival Time:** 700**Prime Contractor:** American Bridge/Fluor Enterprises, a JV**OSM Departure Time:** 1900**Contractor:** Zhenhua Port Machinery Company, Ltd (ZPMC), Changxing Island **Location:** Shanghai, China**CWI Name:** Xu Xian Ping**CWI Present:** Yes No**Inspected CWI report:** Yes No N/A**Rod Oven in Use:** Yes No N/A**Electrode to specification:** Yes No N/A**Weld Procedures Followed:** Yes No N/A**Qualified Welders:** Yes No N/A**Verified Joint Fit-up:** Yes No N/A**Approved Drawings:** Yes No N/A**Approved WPS:** Yes No N/A**Delayed / Cancelled:** Yes No N/A**Bridge No:** 34-0006**Component:** Orthotropic Box Girder (OBG)**Summary of Items Observed:**

WELDING INSPECTION REPORT

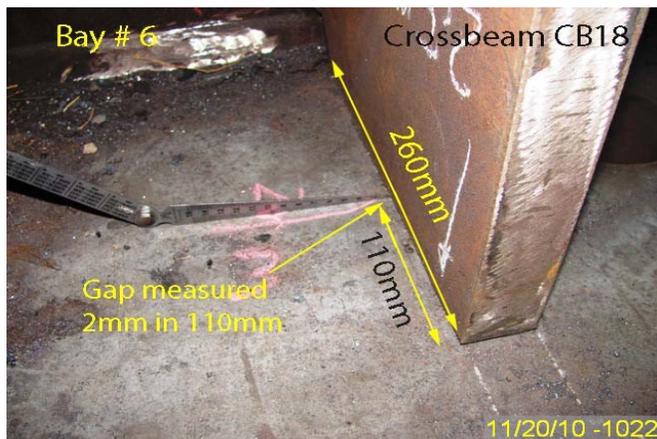
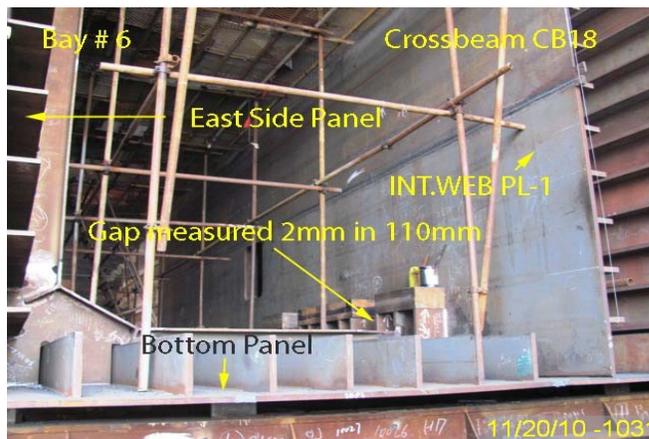
During the Caltrans Quality Assurance in-process observations of the fabrication of Crossbeam CB18, this Quality Assurance Inspector (QA) discovered the following issue. One mill to bear surface that did not appear to comply with the contract documents. Shear key tie down seat vertical stiffener plate to bottom panel gap measured approximately 2mm for approximately 110mm. The total width of the tie down seat vertical stiffener plate is 260mm length. As per approved shop drawing the tie down seat vertical stiffener shall have a mill to bear fit to the bottom panel. The vertical stiffener is near CB3002E Intermediate Web Panel- 1 (East side panel). This QA notified ZPMC QC identified as Mr. Zheng zhi wei of this issue and that an incident report would be generated. For further information, please see the attached pictures below.
