Contract #: 04-0120F4Cty: SF/ALA Rte: 80 PM: 13.2/13.9File #: 69.28**WELDING INSPECTION REPORT****Resident Engineer:** Siegenthaler, Peter**Address:** 333 Burma Road**City:** Oakland, CA 94607**Report No:** WIR-018335**Date Inspected:** 15-Nov-2010**Project Name:** SAS Superstructure**OSM Arrival Time:** 700**Prime Contractor:** American Bridge/Fluor Enterprises, a JV**OSM Departure Time:** 1900**Contractor:** Zhenhua Port Machinery Company, Ltd (ZPMC), Changxing Island **Location:** Shanghai, China**CWI Name:** Xu Le Feng**CWI Present:** Yes No**Inspected CWI report:** Yes No N/A**Rod Oven in Use:** Yes No N/A**Electrode to specification:** Yes No N/A**Weld Procedures Followed:** Yes No N/A**Qualified Welders:** Yes No N/A**Verified Joint Fit-up:** Yes No N/A**Approved Drawings:** Yes No N/A**Approved WPS:** Yes No N/A**Delayed / Cancelled:** Yes No N/A**Bridge No:** 34-0006**Component:** OBG/TOWER**Summary of Items Observed:**

WELDING INSPECTION REPORT

TOWER JETTY

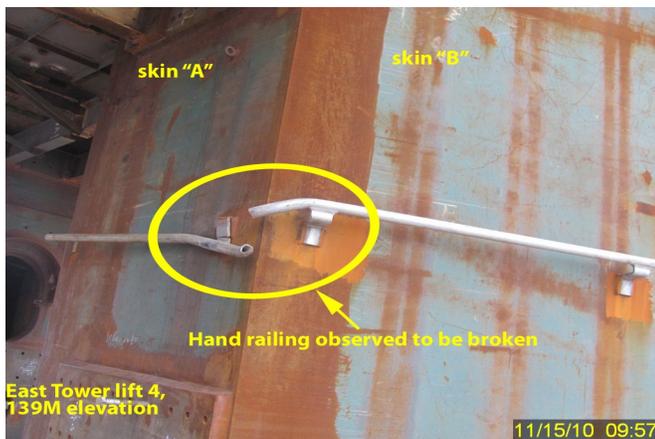
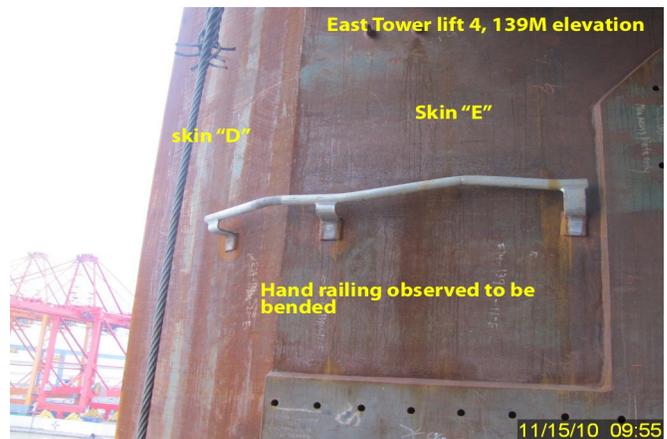
During random in process inspection this QA inspector observed that the hand railing on skin A and skin B of East tower lift 4 at 139M elevation level observed to be bended. The hand railing on skin D and skin E observed to be broken. This issue has been discussed with ZPMC CWI Mr. Zhao Chen Sun and as per discussion ZPMC agreed to replace those broken and bended hand railing as per contract documents. Attached photographs provide additional details.
