DEPARTMENT OF TRANSPORTATION

Quality Assurance and Source Inspection

Contract #: 04-0120F4Cty: SF/ALA Rte: 80 PM: 13.2/13.9File #: 69.28**WELDING INSPECTION REPORT****Resident Engineer:** Siegenthaler, Peter**Address:** 333 Burma Road**City:** Oakland, CA 94607**Report No:** WIR-018348**Date Inspected:** 17-Nov-2010**Project Name:** SAS Superstructure**OSM Arrival Time:** 700**Prime Contractor:** American Bridge/Fluor Enterprises, a JV**OSM Departure Time:** 1900**Contractor:** Zhenhua Port Machinery Company, Ltd (ZPMC), Changxing Island **Location:** Shanghai, China**CWI Name:** Xu Le Feng**CWI Present:** Yes No**Inspected CWI report:** Yes No N/A**Rod Oven in Use:** Yes No N/A**Electrode to specification:** Yes No N/A**Weld Procedures Followed:** Yes No N/A**Qualified Welders:** Yes No N/A**Verified Joint Fit-up:** Yes No N/A**Approved Drawings:** Yes No N/A**Approved WPS:** Yes No N/A**Delayed / Cancelled:** Yes No N/A**Bridge No:** 34-0006**Component:** TOWER & OBG Components**Summary of Items Observed:**

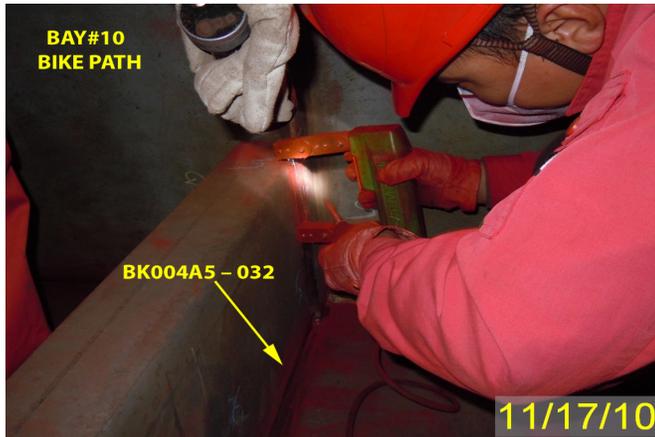
This QA inspector Witnessed MT performed by ZPMC Quality Control personnel. The member is identified as OBG Component. The component designation is identified as follows:

BIKE PATH : BK004A5 – 032 – 018; 019; 58; 59; 38~41

(See attached photo)

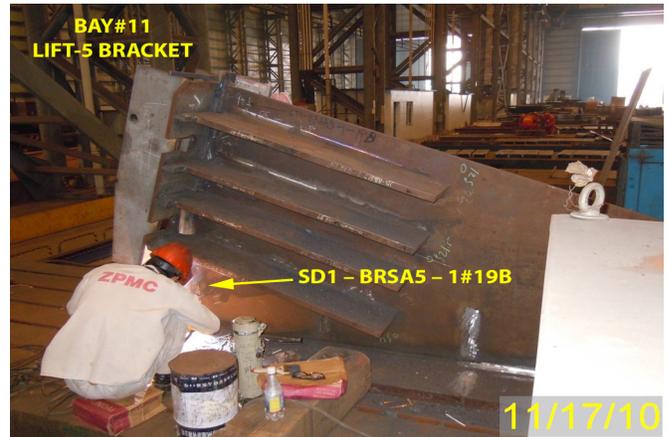
Weld joint # 19B located on Lift-5 bracket SD1 – BRSA5 – 1. Welder is identified as 054460. ZPMC Quality Control (QC) Inspector is identified as Xu Jie. The welding variables recorded by QC appeared to comply with the WPS – B – T – 3213 – TC – U5b. (See attached photo)
