Contract #: 04-0120F4Cty: SF/ALA Rte: 80 PM: 13.2/13.9File #: 69.28**WELDING INSPECTION REPORT****Resident Engineer:** Siegenthaler, Peter**Address:** 333 Burma Road**City:** Oakland, CA 94607**Report No:** WIR-018491**Date Inspected:** 08-Dec-2010**Project Name:** SAS Superstructure**OSM Arrival Time:** 700**Prime Contractor:** American Bridge/Fluor Enterprises, a JV**OSM Departure Time:** 1900**Contractor:** Zhenhua Port Machinery Company, Ltd (ZPMC), Changxing Island **Location:** Shanghai, China**CWI Name:** Guo Yan Fei**CWI Present:** Yes No**Inspected CWI report:** Yes No N/A**Rod Oven in Use:** Yes No N/A**Electrode to specification:** Yes No N/A**Weld Procedures Followed:** Yes No N/A**Qualified Welders:** Yes No N/A**Verified Joint Fit-up:** Yes No N/A**Approved Drawings:** Yes No N/A**Approved WPS:** Yes No N/A**Delayed / Cancelled:** Yes No N/A**Bridge No:** 34-0006**Component:** OBG/TOWER**Summary of Items Observed:**

WELDING INSPECTION REPORT

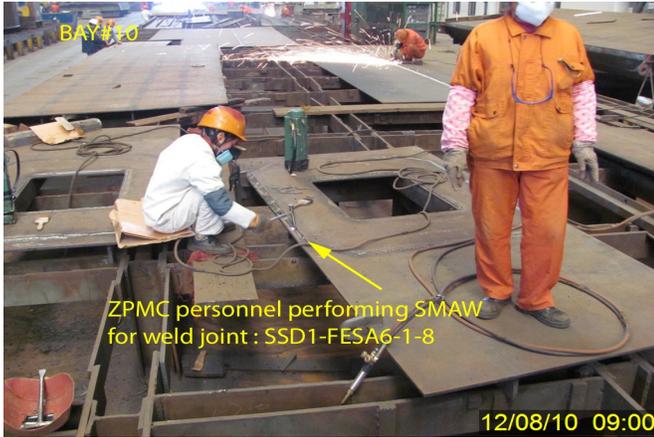
SMAW welding of weld joint no: NSD1-FCSA6-3-05/06 located on Tower Lift 6 Component. Welder is identified as #056364. ZPMC QC is identified as Mr. Li Peng Fei. Welding was performed with the temporary weld repair report. The welding variables recorded by QC appeared to comply with the WPS-345-SMAW-2G(2F)-Repair. Please see the attached picture.

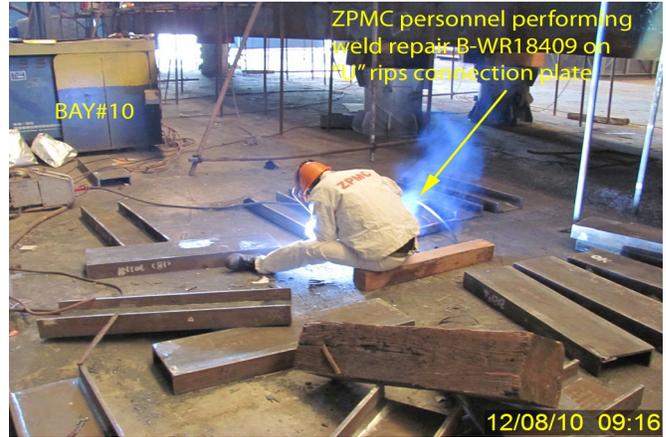
FCAW welding of weld joint no: GGL-MQ-2021-3-2 located on OBG Segment "U" rips connection plate. Welder is identified as #052763. ZPMC QC is identified as Mr. Li Peng Fei. Welding was performed according to the weld repair report B-WR18409 and UT report number: B787-UT-17724. The welding variables recorded by QC appeared to comply with the WPS-345-FCAW-2G(2F)ESAB-Repair. Please see the attached picture.
