DEPARTMENT OF TRANSPORTATION

Quality Assurance and Source Inspection

Contract #: 04-0120F4Cty: SF/ALA Rte: 80 PM: 13.2/13.9File #: 69.28**WELDING INSPECTION REPORT****Resident Engineer:** Siegenthaler, Peter**Address:** 333 Burma Road**City:** Oakland, CA 94607**Report No:** WIR-018497**Date Inspected:** 02-Dec-2010**Project Name:** SAS Superstructure**OSM Arrival Time:** 700**Prime Contractor:** American Bridge/Fluor Enterprises, a JV**OSM Departure Time:** 1900**Contractor:** Zhenhua Port Machinery Company, Ltd (ZPMC), Changxing Island **Location:** Shanghai, China**CWI Name:** Xu Le Feng**CWI Present:** Yes No**Inspected CWI report:** Yes No N/A**Rod Oven in Use:** Yes No N/A**Electrode to specification:** Yes No N/A**Weld Procedures Followed:** Yes No N/A**Qualified Welders:** Yes No N/A**Verified Joint Fit-up:** Yes No N/A**Approved Drawings:** Yes No N/A**Approved WPS:** Yes No N/A**Delayed / Cancelled:** Yes No N/A**Bridge No:** 34-0006**Component:** OBG**Summary of Items Observed:**

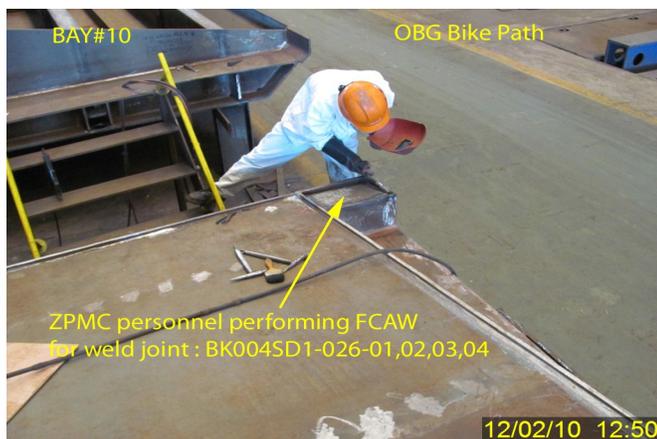
FCAW in the 1G position for the OBG Bike Path, The weld joint was designated as: BK004SD1-026-01,02,03,04.

The welder is identified as #040302. ZPMC QC is identified as Mr. Yu Zhi Lai. The welding variables recorded

by QC appear to comply with WPS-B-T-2231-ESAB. Please see the attached picture.

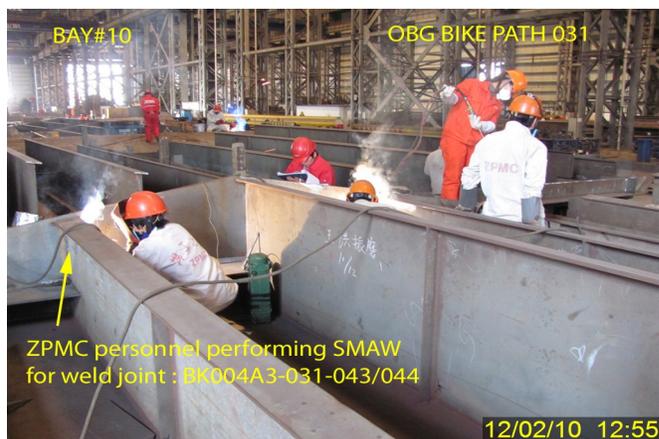
SMAW in the 3F position for the OBG Bike Path, The weld joint was designated as: BK004A3-031-043/044. The welder is identified as #040268. ZPMC QC is identified as Mr. Yu Zhi Lai. The welding variables recorded by QC appear to comply with WPS-B-P-2113. Please see the attached picture.
