DEPARTMENT OF TRANSPORTATION

Quality Assurance and Source Inspection

Contract #: 04-0120F4Cty: SF/ALA Rte: 80 PM: 13.2/13.9File #: 69.28**WELDING INSPECTION REPORT****Resident Engineer:** Siegenthaler, Peter**Address:** 333 Burma Road**City:** Oakland, CA 94607**Report No:** WIR-018498**Date Inspected:** 01-Dec-2010**Project Name:** SAS Superstructure**OSM Arrival Time:** 700**Prime Contractor:** American Bridge/Fluor Enterprises, a JV**OSM Departure Time:** 1900**Contractor:** Zhenhua Port Machinery Company, Ltd (ZPMC), Changxing Island **Location:** Shanghai, China**CWI Name:** Xu Le Feng**CWI Present:** Yes No**Inspected CWI report:** Yes No N/A**Rod Oven in Use:** Yes No N/A**Electrode to specification:** Yes No N/A**Weld Procedures Followed:** Yes No N/A**Qualified Welders:** Yes No N/A**Verified Joint Fit-up:** Yes No N/A**Approved Drawings:** Yes No N/A**Approved WPS:** Yes No N/A**Delayed / Cancelled:** Yes No N/A**Bridge No:** 34-0006**Component:** OBG**Summary of Items Observed:**

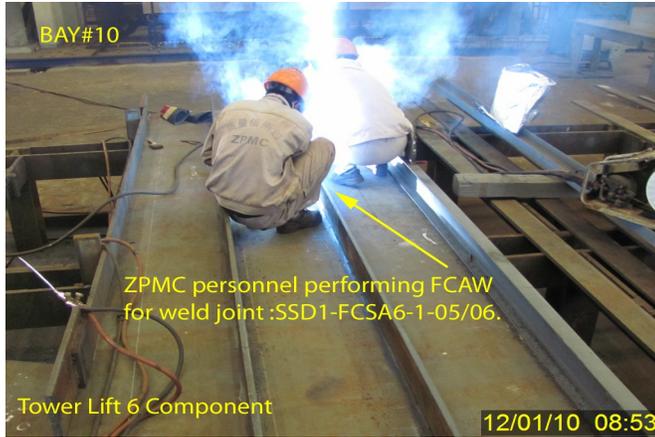
FCAW in the 2F position for the Tower Lift 6 Component, The weld joint was designated as:

SSD1-FCSA6-1-05/06. The welders are identified as #040367/040458. ZPMC QC is identified as Mr. Li Peng Fei.

The welding variables recorded by QC appear to comply with WPS-B-T-2132. Please see the attached picture.

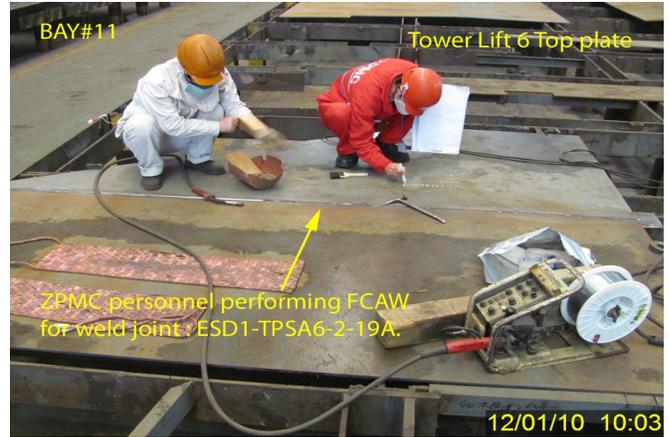
FCAW in the 1G position for the Tower Lift 6 Top plate, The weld joint was designated as: ESD1-TPSA6-2-19A.

The welder is identified as #040723. ZPMC QC is identified as Mr. Mao Bin Bin. The welding variables recorded by QC appear to comply with WPS-B-T-2231-B-U2-F. Please see the attached picture.
