DEPARTMENT OF TRANSPORTATION

Quality Assurance and Source Inspection

Contract #: 04-0120F4Cty: SF/ALA Rte: 80 PM: 13.2/13.9File #: 69.28**WELDING INSPECTION REPORT****Resident Engineer:** Siegenthaler, Peter**Address:** 333 Burma Road**City:** Oakland, CA 94607**Report No:** WIR-018537**Date Inspected:** 04-Dec-2010**Project Name:** SAS Superstructure**OSM Arrival Time:** 700**Prime Contractor:** American Bridge/Fluor Enterprises, a JV**OSM Departure Time:** 1900**Contractor:** Zhenhua Port Machinery Company, Ltd (ZPMC), Changxing Island **Location:** Shanghai, China**CWI Name:** Shi Lei**CWI Present:** Yes No**Inspected CWI report:** Yes No N/A**Rod Oven in Use:** Yes No N/A**Electrode to specification:** Yes No N/A**Weld Procedures Followed:** Yes No N/A**Qualified Welders:** Yes No N/A**Verified Joint Fit-up:** Yes No N/A**Approved Drawings:** Yes No N/A**Approved WPS:** Yes No N/A**Delayed / Cancelled:** Yes No N/A**Bridge No:** 34-0006**Component:** OBG COMPONENT**Summary of Items Observed:**

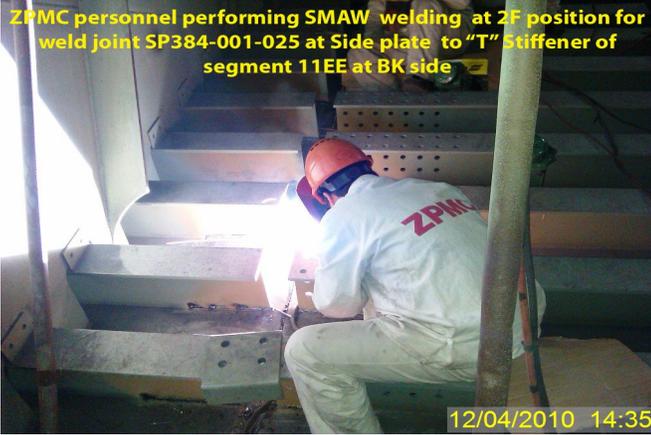
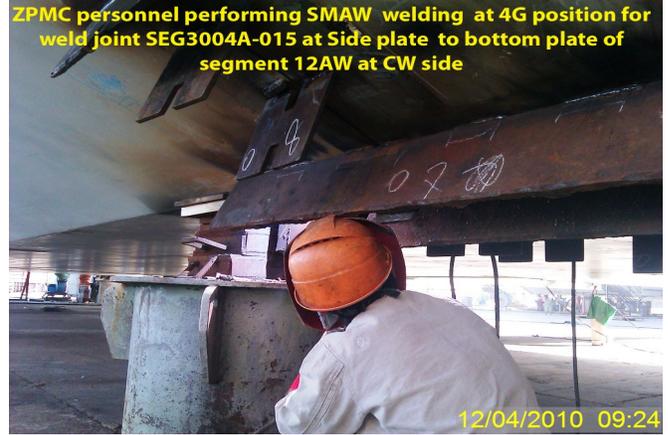
This QA Inspector observed the following work in progress:

SMAW in the 4G position for the OBG segment 12AW, weld No. SEG3004A-015 at Counter weight side. The welder is identified as #046709. ZPMC QC is identified as Mr. Zhu Zhong Hai. The welding variables recorded by QC appear to comply with WPS-B-P-2214-B-U2-FCM-1.

SMAW in the 4G position for the OBG segment 11EW, weld No. SEG073A-011 at Counter weight side. The welder is identified as #046709. ZPMC QC is identified as Mr. Zhu Zhong Hai. The welding variables recorded by QC appear to comply with WPS-B-P-2214-B-U2-FCM-1.

SMAW in the 4F position for the OBG segment 11DE, weld No. OBE11A-016. The welder is identified as #067765. ZPMC QC is identified as Mr. Zhang Qing. The welding variables recorded by QC appear to comply with WPS-B-P-2114-FCM-1.

SMAW in the 4F position for the OBG segment 11EE , weld No.OBE11A-019. The welder is identified as #067765. ZPMC QC is identified as Mr. Zhang Qing. The welding variables recorded by QC appear to comply with WPS-B-P-2114 -FCM-1.

SMAW in the 2F position for the OBG segment 11EE , weld No.SP384-001-026. The welder is identified as #040320. ZPMC QC is identified as Mr. An Qing Xiang. The welding variables recorded by QC appear to comply with WPS-B-P-2114 -FCM-1.
