DEPARTMENT OF TRANSPORTATION

Contract #: 04-0120F4Cty: SF/ALA Rte: 80 PM: 13.2/13.9File #: 69.28**WELDING INSPECTION REPORT****Resident Engineer:** Siegenthaler, Peter**Address:** 333 Burma Road**City:** Oakland, CA 94607**Report No:** WIR-018546**Date Inspected:** 07-Dec-2010**Project Name:** SAS Superstructure**OSM Arrival Time:** 645**Prime Contractor:** American Bridge/Fluor Enterprises, a JV**OSM Departure Time:** 1845**Contractor:** Zhenhua Port Machinery Company, Ltd (ZPMC), Changxing Island **Location:** Shanghai, China**CWI Name:** Zhu Zhong Hai.**CWI Present:** Yes No**Inspected CWI report:** Yes No N/A**Rod Oven in Use:** Yes No N/A**Electrode to specification:** Yes No N/A**Weld Procedures Followed:** Yes No N/A**Qualified Welders:** Yes No N/A**Verified Joint Fit-up:** Yes No N/A**Approved Drawings:** Yes No N/A**Approved WPS:** Yes No N/A**Delayed / Cancelled:** Yes No N/A**Bridge No:** 34-0006**Component:** Orthotropic Box Girder (OBG)**Summary of Items Observed:**

Trial assembly yard, 12AW-12BW, Bottom plate T-rib splice.

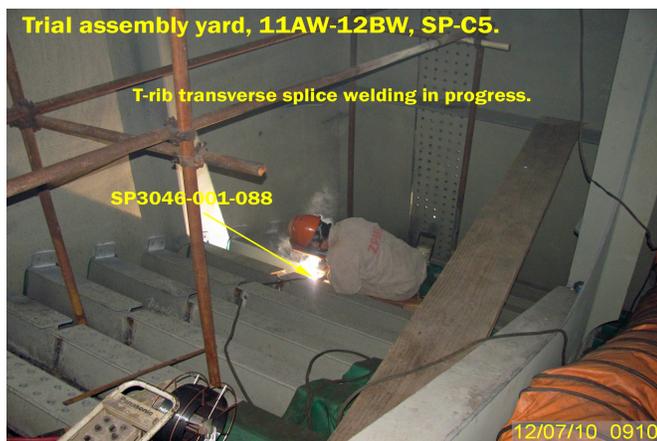
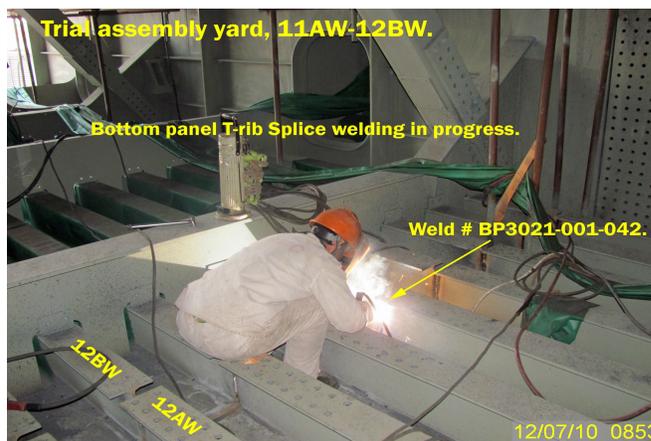
SMAW welding of weld joint BP3021-001-42; located at Trial assembly yard. Welder is identified as 057333; ZPMC Quality Control Inspector (QC) is identified as Zhu zhong hai. The welding variables recorded by Quality Control Inspector (QC) appeared to comply with the Applicable WPS: WPS-B-P-2213-B-U2-FCM-1. The attached photographs provide additional detail.

SMAW welding of weld joint SP3046-001-88; located at Trial assembly yard. Welder is identified as 046704; ZPMC Quality Control Inspector (QC) is identified as Zhu zhong hai. The welding variables recorded by Quality Control Inspector (QC) appeared to comply with the Applicable WPS: WPS-B-P-2213-B-U2-FCM-1. The attached photographs provide additional detail.
