Contract #: 04-0120F4Cty: SF/ALA Rte: 80 PM: 13.2/13.9File #: 82.28**WELDING INSPECTION REPORT****Resident Engineer:** Siegenthaler, Peter**Address:** 333 Burma Road**City:** Oakland, CA 94607**Report No:** WIR-018573**Date Inspected:** 03-Dec-2010**Project Name:** SAS Superstructure**OSM Arrival Time:** 700**Prime Contractor:** American Bridge/Fluor Enterprises, a JV**OSM Departure Time:** 1530**Contractor:** Westmont Industries**Location:** Santa Fe Springs, CA.**CWI Name:** Ruben Dominguez**CWI Present:** Yes No**Inspected CWI report:** Yes No N/A**Rod Oven in Use:** Yes No N/A**Electrode to specification:** Yes No N/A**Weld Procedures Followed:** Yes No N/A**Qualified Welders:** Yes No N/A**Verified Joint Fit-up:** Yes No N/A**Approved Drawings:** Yes No N/A**Approved WPS:** Yes No N/A**Delayed / Cancelled:** Yes No N/A**Bridge No:** 34-0006**Component:** Travelers**Summary of Items Observed:**

SAS-EB Traveler**Fixed Stairs Section**

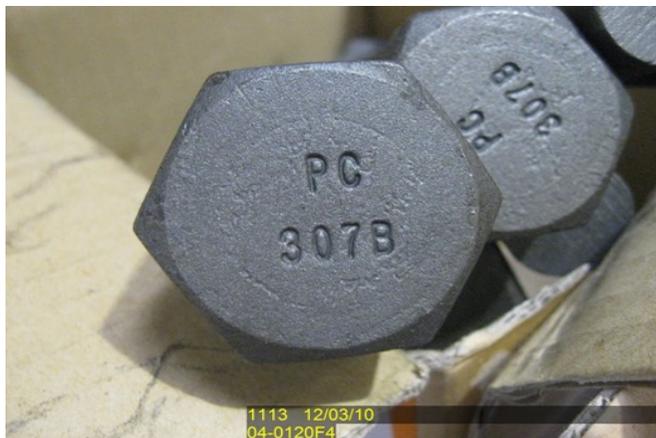
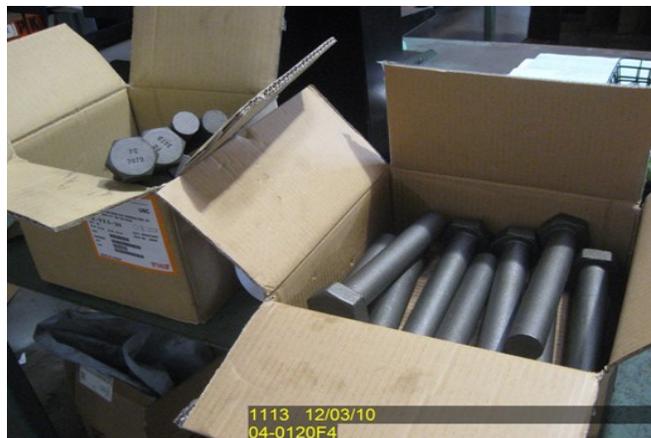
Once again, the QA Inspector then arrived at Pacific Bolt as requested and proceeded to perform an inspection on the above mentioned material. After inspection, the QA Inspector observed that the material appeared to be in compliance with the contract requirements and is listed as follows:

9 each 1.25" x 4.172" ASTM A307 Gr. B Rounds

7 each 1.125" x 3.5" ASTM A307 Gr. B Rounds

See attached pictures below.
