Contract #: 04-0120F4Cty: SF/ALA Rte: 80 PM: 13.2/13.9File #: 69.28**WELDING INSPECTION REPORT****Resident Engineer:** Siegenthaler, Peter**Address:** 333 Burma Road**City:** Oakland, CA 94607**Report No:** WIR-018615**Date Inspected:** 10-Dec-2010**Project Name:** SAS Superstructure**OSM Arrival Time:** 645**Prime Contractor:** American Bridge/Fluor Enterprises, a JV**OSM Departure Time:** 1845**Contractor:** Zhenhua Port Machinery Company, Ltd (ZPMC), Changxing Island **Location:** Shanghai, China**CWI Name:** Shi Lei.**CWI Present:** Yes No**Inspected CWI report:** Yes No N/A**Rod Oven in Use:** Yes No N/A**Electrode to specification:** Yes No N/A**Weld Procedures Followed:** Yes No N/A**Qualified Welders:** Yes No N/A**Verified Joint Fit-up:** Yes No N/A**Approved Drawings:** Yes No N/A**Approved WPS:** Yes No N/A**Delayed / Cancelled:** Yes No N/A**Bridge No:** 34-0006**Component:** Orthotropic Box Girder (OBG)**Summary of Items Observed:**

WELDING INSPECTION REPORT

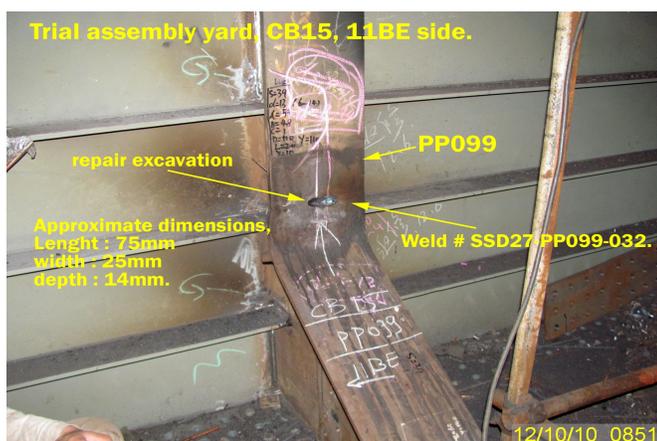
Trial assembly yard, CB15, PP099, 11BE side.

During Random Visual in process Inspection, this QA inspector observed repair excavation of butt joint at partial diaphragm inside Crossbeam 15. This QA inspector has been informed that the excavation was performed according to ZPMC UT report "B787-UT-16472"; ZPMC Quality Control Inspector (QC) is identified as Zhu Zhong Hai. The attached photographs provide additional detail.

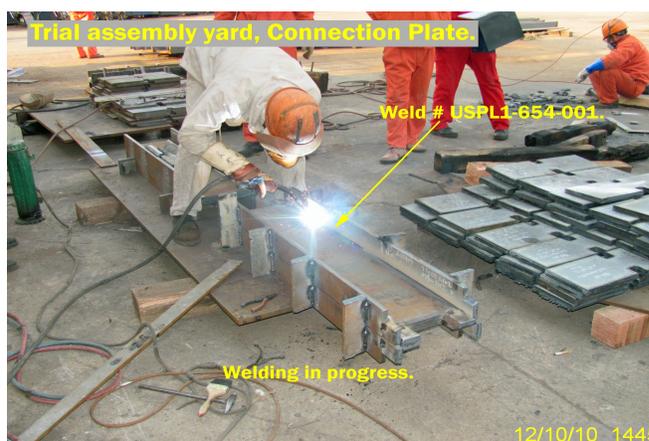
Trial assembly yard, Connection Plate.

FCAW welding of weld joint USPL1-654-001; located at Trial assembly yard. Welder is identified as 053486; ZPMC Quality Control Inspector (QC) is identified as Zhu Zhong Hai. The welding variables recorded by Quality Control Inspector (QC) appeared to comply with the Applicable WPS: WPS-B-T-2231-ESAB. The attached photographs provide additional detail.
