DEPARTMENT OF TRANSPORTATION

Contract #: 04-0120F4Cty: SF/ALA Rte: 80 PM: 13.2/13.9File #: 69.28**WELDING INSPECTION REPORT****Resident Engineer:** Siegenthaler, Peter**Address:** 333 Burma Road**City:** Oakland, CA 94607**Report No:** WIR-018624**Date Inspected:** 14-Dec-2010**Project Name:** SAS Superstructure**OSM Arrival Time:** 700**Prime Contractor:** American Bridge/Fluor Enterprises, a JV**OSM Departure Time:** 1900**Contractor:** Zhenhua Port Machinery Company, Ltd (ZPMC), Changxing Island **Location:** Shanghai, China**CWI Name:** Xu tao**CWI Present:** Yes No**Inspected CWI report:** Yes No N/A**Rod Oven in Use:** Yes No N/A**Electrode to specification:** Yes No N/A**Weld Procedures Followed:** Yes No N/A**Qualified Welders:** Yes No N/A**Verified Joint Fit-up:** Yes No N/A**Approved Drawings:** Yes No N/A**Approved WPS:** Yes No N/A**Delayed / Cancelled:** Yes No N/A**Bridge No:** 34-0006**Component:** OBG Components**Summary of Items Observed:**

WELDING INSPECTION REPORT

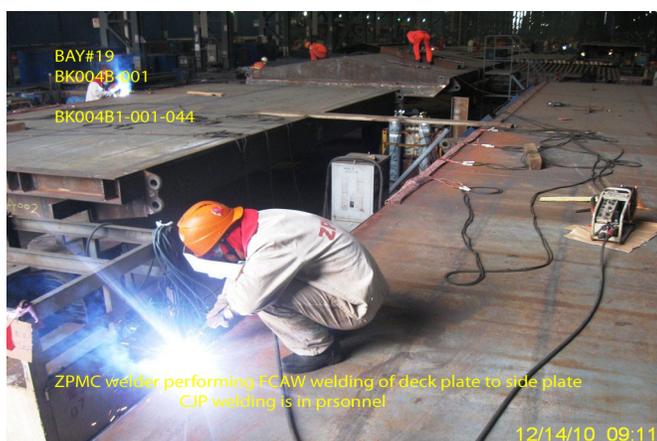
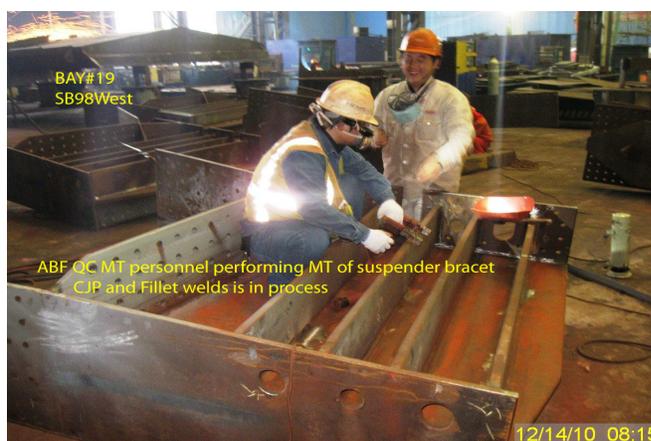
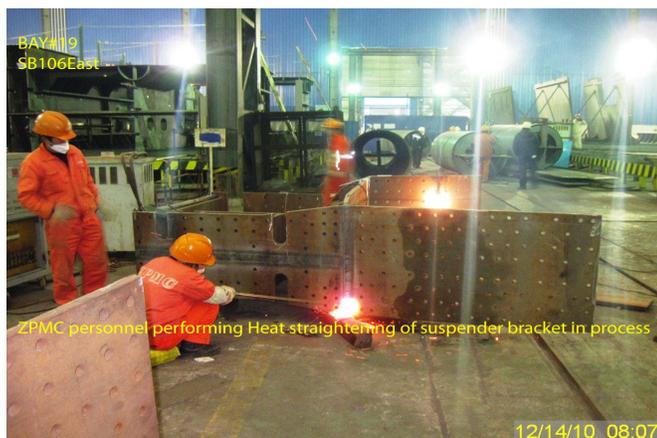
FCAW welding of weld is identified as 1G-044 of BK005A1-002 for BK005A-002. The welder is identified as 062783. ZPMC QC is identified as Mr. Xu tao. The welding variables recorded by QC are appeared to comply with the WPS-B-T-2231-ESAB.

FCAW welding of weld is identified as 1G-044 of BK004B-001 for BK004B-001. The welder is identified as 062762. ZPMC QC is identified as Mr. Xu tao. The welding variables recorded by QC are appeared to comply with the WPS-B-T-2231-ESAB.

Witness of ABF QC MT personnel performing MT of after back gouged location of complete penetration joint (CJP) is identified as BK004B1-044 for BK004A-001.

ZPMC personnel performing Heat straightening of bike path bottom covering plate is in progress. The bike path is identified as BK004A-006.

ZPMC personnel performing Heat straightening of Suspender bracket web to side plate is in progress. The suspender is identified as SB106East for Lift-11.

ABF QC MT personnel performing of MT of suspender bracket is in progress, the suspender bracket is identified as SB98West.
