**DEPARTMENT OF TRANSPORTATION**

Contract #: 04-0120F4Cty: SF/ALA Rte: 80 PM: 13.2/13.9File #: 69.28**WELDING INSPECTION REPORT****Resident Engineer:** Siegenthaler, Peter**Address:** 333 Burma Road**City:** Oakland, CA 94607**Report No:** WIR-018647**Date Inspected:** 16-Oct-2010**Project Name:** SAS Superstructure**OSM Arrival Time:** 1500**Prime Contractor:** American Bridge/Fluor Enterprises, a JV**OSM Departure Time:** 300**Contractor:** Zhenhua Port Machinery Company, Ltd (ZPMC), Changxing Island **Location:** ShangHai, China**CWI Name:** Chen Xi**CWI Present:** Yes No**Inspected CWI report:** Yes No N/A**Rod Oven in Use:** Yes No N/A**Electrode to specification:** Yes No N/A**Weld Procedures Followed:** Yes No N/A**Qualified Welders:** Yes No N/A**Verified Joint Fit-up:** Yes No N/A**Approved Drawings:** Yes No N/A**Approved WPS:** Yes No N/A**Delayed / Cancelled:** Yes No N/A**Bridge No:** 34-0006**Component:** OBG**Summary of Items Observed:**

## WELDING INSPECTION REPORT

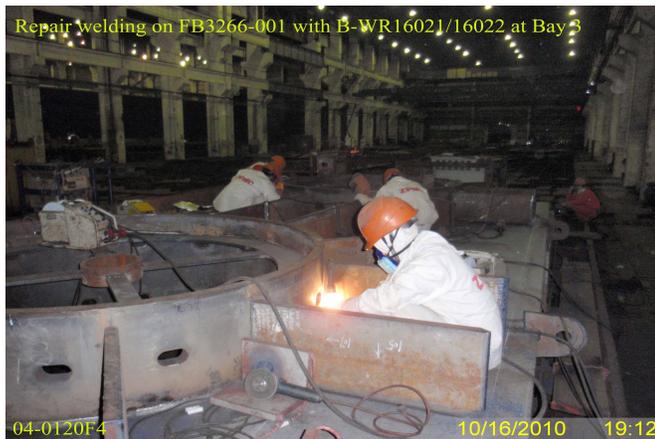
This QA inspector performed Magnetic Particle Testing (MT) and Visual Inspection (VT) of approximately 15 % of the area previously tested and accepted by ZPMC Quality Control personnel. This QA Inspector generated an MT report for this date. The member(s) is/are identified as follows; RETRO-B2-10BE for item number 1 on NWIT tracker document # 06987.

Unless otherwise noted, all work observed on this date appeared to generally comply with applicable contract documents.
