DEPARTMENT OF TRANSPORTATION

Quality Assurance and Source Inspection

Contract #: 04-0120F4Cty: SF/ALA Rte: 80 PM: 13.2/13.9File #: 1.28**WELDING INSPECTION REPORT****Resident Engineer:** Siegenthaler, Peter**Address:** 333 Burma Road**City:** Oakland, CA 94607**Report No:** WIR-018711**Date Inspected:** 18-Dec-2010**Project Name:** SAS Superstructure**OSM Arrival Time:** 630**Prime Contractor:** American Bridge/Fluor Enterprises, a JV**OSM Departure Time:** 1500**Contractor:** American Bridge/Fluor Enterprises, a JV**Location:** Job Site**CWI Name:** As noted in Summary**CWI Present:** Yes No**Inspected CWI report:** Yes No N/A**Rod Oven in Use:** Yes No N/A**Electrode to specification:** Yes No N/A**Weld Procedures Followed:** Yes No N/A**Qualified Welders:** Yes No N/A**Verified Joint Fit-up:** Yes No N/A**Approved Drawings:** Yes No N/A**Approved WPS:** Yes No N/A**Delayed / Cancelled:** Yes No N/A**Bridge No:** 34-0006**Component:** Orthotropic Box Girder**Summary of Items Observed:**

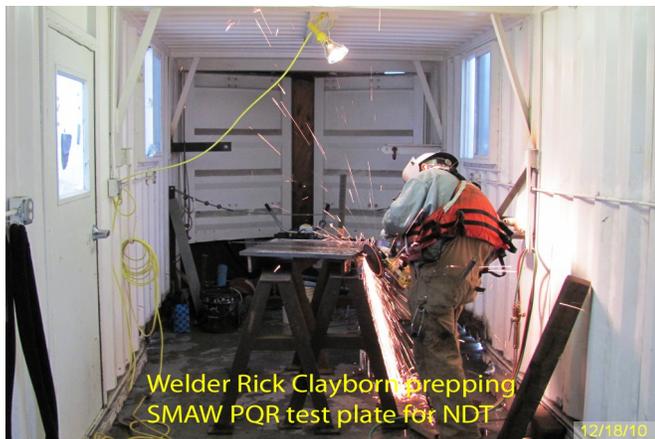
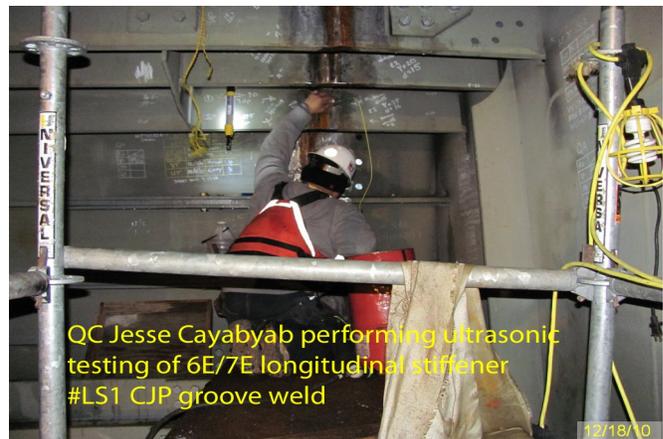
On this date, the QA inspector observed American Bridge welding personnel Rick Clayborn removing the weld reinforcement by grinding to a smooth flush profile of ASTM – A709 485W HPS Procedure Qualification (PQR) test plate designated ABF-PQR-038-3 that was welded using shielded metal arc welding (SMAW) using Lincoln Excalibur E9018-M-H4R electrode. The Smith Emery QC Inspector Michael Johnson reported that the test plate was visually acceptable. Mr. Johnson requested that test plate be released to Construction Materials Testing for Radiographic testing. The actual welding of the test plate was performed on Friday Dec 17 2010 and was witnessed by QAIs Fred Edmondson and Joselito Lizardo. Mr. Lizardo found the completed weld to have underfill in accordance with AWS D1.5 requirements.

The Caltrans QA inspector assigned a Structures Materials Representative (SMR) Lot Number S014-001 as directed by Pat Lowry and the plate will be shipped to Construction Materials Testing for Radiographic testing. Caltrans lot number B31-037-10A was assigned for tracking purposes. See METS TL-6032 for more information.
