DEPARTMENT OF TRANSPORTATION

Contract #: 04-0120F4Cty: SF/ALA Rte: 80 PM: 13.2/13.9File #: 69.28**WELDING INSPECTION REPORT****Resident Engineer:** Siegenthaler, Peter**Address:** 333 Burma Road**City:** Oakland, CA 94607**Report No:** WIR-018752**Date Inspected:** 10-Oct-2010**Project Name:** SAS Superstructure**OSM Arrival Time:** 700**Prime Contractor:** American Bridge/Fluor Enterprises, a JV**OSM Departure Time:** 1900**Contractor:** Zhenhua Port Machinery Company, Ltd (ZPMC), Changxing Island **Location:** Shanghai, China

WELDING INSPECTION REPORT

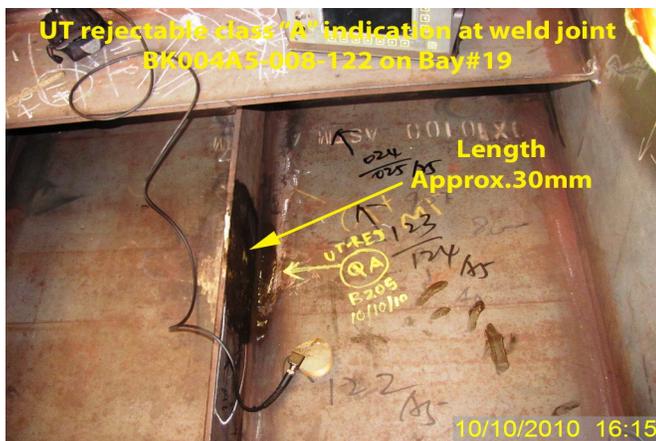
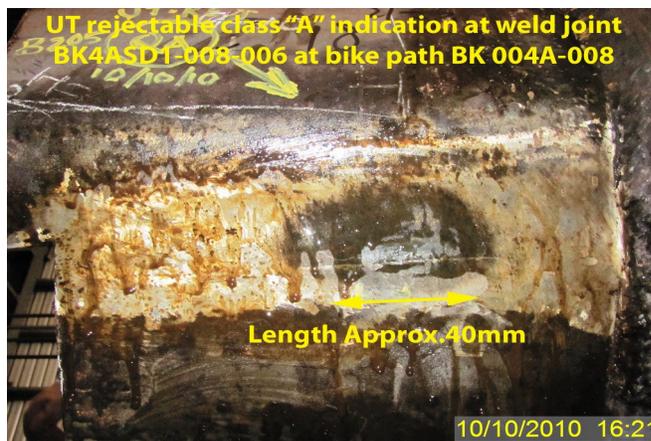
During the Quality Assurance Ultrasonic Testing (UT) review of (2) welds located on OBG Bike Path, these Quality Assurance Inspectors (QA) discovered the following issues two (2) Class “A” indications measuring approximately 30-35mm in length. The welds are Complete Joint Penetration butt joints joining the stiffener to stiffener. The Indication rating is +8dB and length approximately 30mm. The depth of the indication approximately 8mm for weld BK004A5-008-122. The “Y” location for this indication approximately 50mm from deck plate. And the Indication rating is +1dB and length approximately 40mm for weld joint BK4ASD1-008-006. The depth of the indication approximately 12mm for weld BK4ASD1-008-006. The “Y” location for this indication approximately 250mm from edge of plate. The indications are clearly marked by the QA Inspectors near the weld. These welds joints are designated as non Seismic Performance Critical Member (non SPCM). The OBG Bike Paths are located in the inside of fabrication bay 19. The Notice of Witness Inspection Number (NWIT) is 006908. The indications are located within the area that has been previously tested and accepted by ZPMC Quality Control (QC) personnel. As per the contract documents, ZPMC’s QC personnel are required to perform 100% UT inspection of this weld.

The QA inspector Mr. Vibin Kumar to made an incident report on this date.
