**DEPARTMENT OF TRANSPORTATION**

Contract #: 04-0120F4Cty: SF/ALA Rte: 80 PM: 13.2/13.9File #: 69.28**WELDING INSPECTION REPORT****Resident Engineer:** Siegenthaler, Peter**Address:** 333 Burma Road**City:** Oakland, CA 94607**Report No:** WIR-018758**Date Inspected:** 17-Nov-2010**Project Name:** SAS Superstructure**OSM Arrival Time:** 1900**Prime Contractor:** American Bridge/Fluor Enterprises, a JV**OSM Departure Time:** 700**Contractor:** Zhenhua Port Machinery Company, Ltd (ZPMC), Changxing Island **Location:** Shanghai, China**CWI Name:** See Below**CWI Present:** Yes No**Inspected CWI report:** Yes No N/A**Rod Oven in Use:** Yes No N/A**Electrode to specification:** Yes No N/A**Weld Procedures Followed:** Yes No N/A**Qualified Welders:** Yes No N/A**Verified Joint Fit-up:** Yes No N/A**Approved Drawings:** Yes No N/A**Approved WPS:** Yes No N/A**Delayed / Cancelled:** Yes No N/A**Bridge No:** 34-0006**Component:** OBG**Summary of Items Observed:**

OBG Bay 13

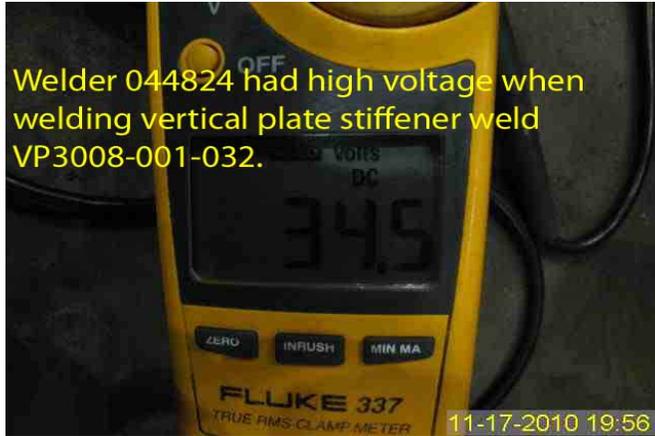
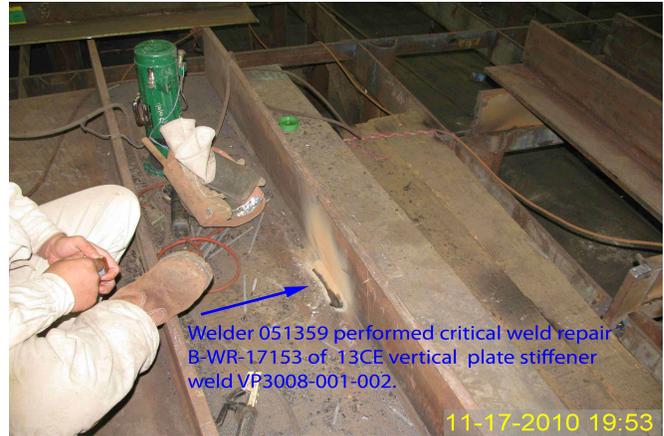
This QA Inspector observed ZPMC welder Mr. Chen Chuanzong, stencil 044824 used flux cored arc welding procedure specification WPS-345-FCAW-2G(2F)-Repair to make repairs of OBG segment 13CE vertical plate stiffener weld VP3008-001-032 in accordance with weld repair document B-WR-17159. This weld had been ultrasonically rejected. This QA Inspector observed a welding current of approximately 305 amps and 34.5 volts. This QA Inspector observed that the maximum welding voltage in the WPS is 32.5 volts and that Mr. Chen Chuanzong had a welding current that was approximately 2.0 volts above this maximum limit. This QA Inspector showed CWI Mr. Li Ming Yang the welding voltage meter and he agreed the welding voltage was above the maximum and the welding voltage was adjusted to approximately 32 volts. This QA Inspector observed the base materials were heated with electric heaters to preheat and maintain the base material temperature of this weld joint. Following adjustment of the welding voltage, items observed on this date appeared to generally comply with applicable contract documents. See the photograph below for additional information.
