Contract #: 04-0120F4Cty: SF/ALA Rte: 80 PM: 13.2/13.9File #: 69.28**WELDING INSPECTION REPORT****Resident Engineer:** Siegenthaler, Peter**Address:** 333 Burma Road**City:** Oakland, CA 94607**Report No:** WIR-018770**Date Inspected:** 21-Dec-2010**Project Name:** SAS Superstructure**OSM Arrival Time:** 700**Prime Contractor:** American Bridge/Fluor Enterprises, a JV**OSM Departure Time:** 1900**Contractor:** Zhenhua Port Machinery Company, Ltd (ZPMC), Changxing Island **Location:** Shanghai, China**CWI Name:** Zhou Zhong Hai**CWI Present:** Yes No**Inspected CWI report:** Yes No N/A**Rod Oven in Use:** Yes No N/A**Electrode to specification:** Yes No N/A**Weld Procedures Followed:** Yes No N/A**Qualified Welders:** Yes No N/A**Verified Joint Fit-up:** Yes No N/A**Approved Drawings:** Yes No N/A**Approved WPS:** Yes No N/A**Delayed / Cancelled:** Yes No N/A**Bridge No:** 34-0006**Component:** OBG Segments**Summary of Items Observed:**

On this date Caltrans OSM Quality Assurance (QA) Inspector, Dan Hernandez was present during the times noted above to observe the fit up, welding and related activities associated with the fabrication of the San Francisco Oakland Bay Self Anchored S

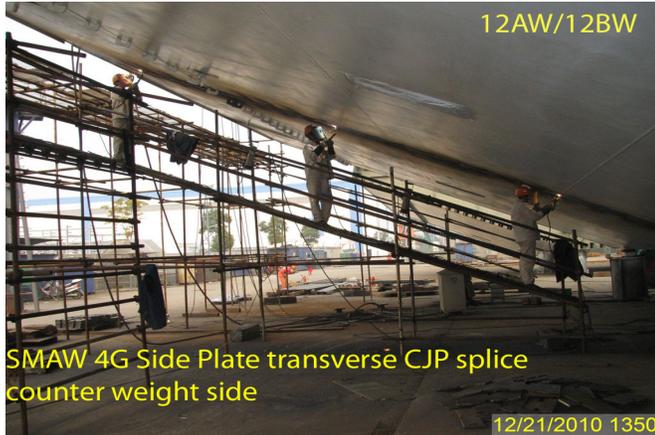
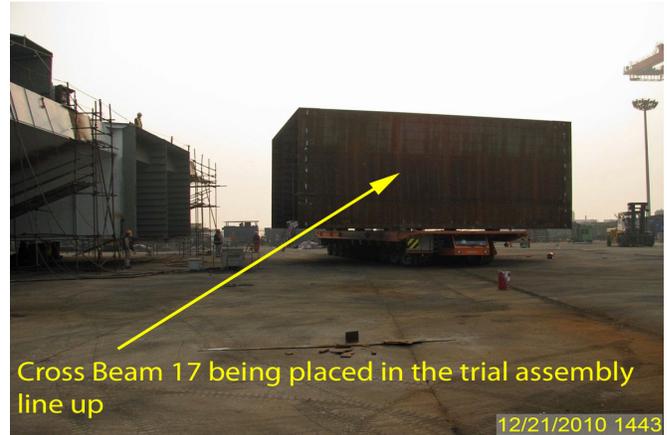
This QA Inspector observed CB17 being placed in the OBG Trial Assembly Line up..

Unless otherwise noted, all work observed on this date appeared to generally comply with applicable contract documents.
