**DEPARTMENT OF TRANSPORTATION**

Contract #: 04-0120F4Cty: SF/ALA Rte: 80 PM: 13.2/13.9File #: 69.28**WELDING INSPECTION REPORT****Resident Engineer:** Siegenthaler, Peter**Address:** 333 Burma Road**City:** Oakland, CA 94607**Report No:** WIR-018784**Date Inspected:** 27-Nov-2010**Project Name:** SAS Superstructure**OSM Arrival Time:** 1900**Prime Contractor:** American Bridge/Fluor Enterprises, a JV**OSM Departure Time:** 700**Contractor:** Zhenhua Port Machinery Company, Ltd (ZPMC), Changxing Island **Location:** Shanghai, China**CWI Name:** See Below**CWI Present:** Yes No**Inspected CWI report:** Yes No N/A**Rod Oven in Use:** Yes No N/A**Electrode to specification:** Yes No N/A**Weld Procedures Followed:** Yes No N/A**Qualified Welders:** Yes No N/A**Verified Joint Fit-up:** Yes No N/A**Approved Drawings:** Yes No N/A**Approved WPS:** Yes No N/A**Delayed / Cancelled:** Yes No N/A**Bridge No:** 34-0006**Component:** OBG**Summary of Items Observed:**

**OBG Bay 14**

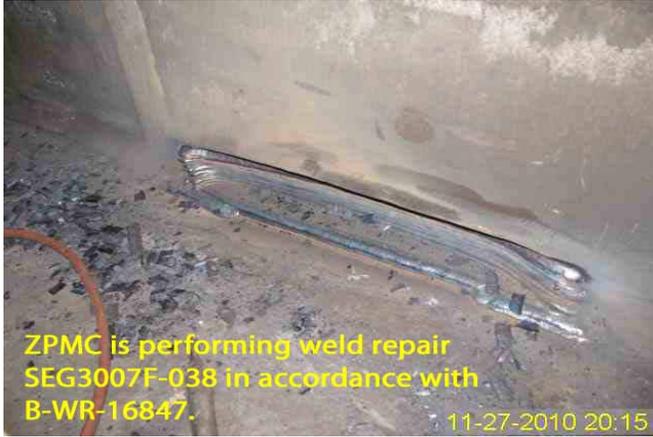
This QA Inspector observed ZPMC welder Mr. Zhang Quin Quan, stencil 044774 used flux cored welding procedure WPS-345-FCAW-2G(2F)-Repair-1 to make OBG segment 13AE weld repair SEG3007F-017 per weld repair document B-WR17556. This weld had been rejected by ZPMC personnel during ultrasonic inspections. This QA Inspector observed a welding current of 315 amps and 30.5 volts. This QA Inspector observed that Mr. Zhang Quin Quan appeared to be certified to make this weld. Items observed on this date appeared to generally comply with applicable contract documents.

See the photograph below for additional information.
