DEPARTMENT OF TRANSPORTATION

Quality Assurance and Source Inspection

Contract #: 04-0120F4Cty: SF/ALA Rte: 80 PM: 13.2/13.9File #: 69.28**WELDING INSPECTION REPORT****Resident Engineer:** Siegenthaler, Peter**Address:** 333 Burma Road**City:** Oakland, CA 94607**Report No:** WIR-018811**Date Inspected:** 20-Dec-2010**Project Name:** SAS Superstructure**OSM Arrival Time:** 700**Prime Contractor:** American Bridge/Fluor Enterprises, a JV**OSM Departure Time:** 1900**Contractor:** Zhenhua Port Machinery Company, Ltd (ZPMC), Changxing Island **Location:** Shanghai, China**CWI Name:** Zhu Zhong Hai**CWI Present:** Yes No**Inspected CWI report:** Yes No N/A**Rod Oven in Use:** Yes No N/A**Electrode to specification:** Yes No N/A**Weld Procedures Followed:** Yes No N/A**Qualified Welders:** Yes No N/A**Verified Joint Fit-up:** Yes No N/A**Approved Drawings:** Yes No N/A**Approved WPS:** Yes No N/A**Delayed / Cancelled:** Yes No N/A**Bridge No:** 34-0006**Component:** Orthotropic Box Girder (OBG)**Summary of Items Observed:**

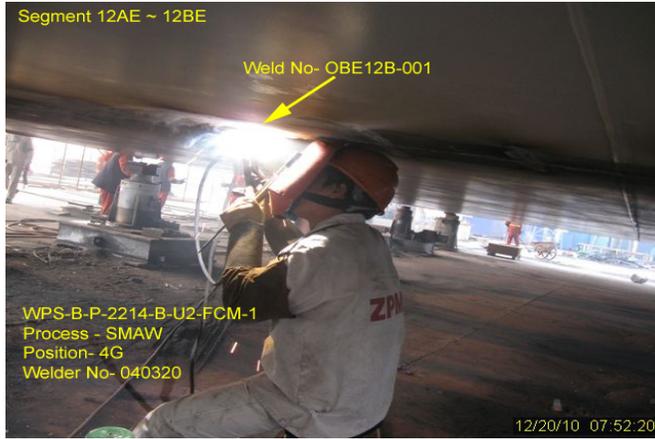
Segment 12AE ~ 12BE

This QA Inspector observed ZPMC qualified welding personnel identified as 040320 perform Shielded Metal Arc Welding (SMAW), weld joint identified as OBE12B-001; located On Orthotropic Box Girder (OBG) Bottom Plate to Bottom Plate Transverse Splice CJP Weld; ZPMC Quality Control (QC) is identified as Mr. Liu Hua Jie. The welding variables recorded by QC appeared to comply with applicable WPS-B-P-2214-B-U2-FCM-1. See attached photo for further details.

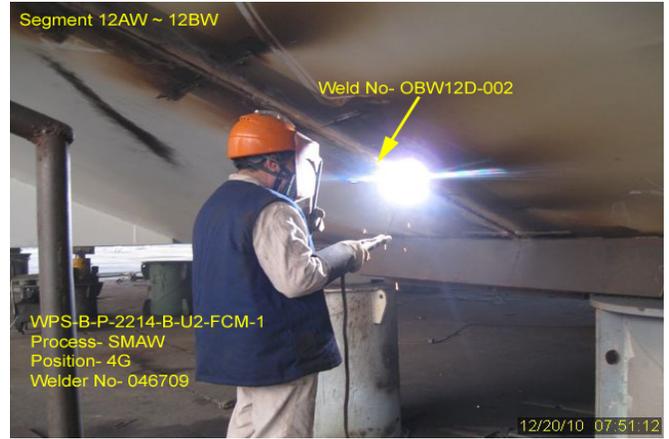
Segment 12AW ~ 12BW

This QA Inspector observed ZPMC qualified welding personnel identified as 046709 perform Flux Core Arc Welding (FCAW), weld joint identified as OBW12D-002; located On Orthotropic Box Girder (OBG) Side Plate to Side Plate CJP Weld; ZPMC Quality Control (QC) is identified as Mr. Zhu Zhong Hai. The welding variables recorded by QC appeared to comply with applicable WPS-B-P-2214-B-U2-FCM-1. See attached photo for further details.
