Quality Assurance and Source Inspection

Contract #: 04-0120F4Cty: SF/ALA Rte: 80 PM: 13.2/13.9File #: 69.28**WELDING INSPECTION REPORT****Resident Engineer:** Siegenthaler, Peter**Address:** 333 Burma Road**City:** Oakland, CA 94607**Report No:** WIR-018831**Date Inspected:** 17-Dec-2010**Project Name:** SAS Superstructure**OSM Arrival Time:** 700**Prime Contractor:** American Bridge/Fluor Enterprises, a JV**OSM Departure Time:** 1700**Contractor:** Zhenhua Port Machinery Company, Ltd (ZPMC), Changxing Island **Location:** Shanghai, China**CWI Name:** Mr. Li jia**CWI Present:** Yes No**Inspected CWI report:** Yes No N/A**Rod Oven in Use:** Yes No N/A**Electrode to specification:** Yes No N/A**Weld Procedures Followed:** Yes No N/A**Qualified Welders:** Yes No N/A**Verified Joint Fit-up:** Yes No N/A**Approved Drawings:** Yes No N/A**Approved WPS:** Yes No N/A**Delayed / Cancelled:** Yes No N/A**Bridge No:** 34-0006**Component:** Orthotropic Box Girder (OBG)**Summary of Items Observed:**

WELDING INSPECTION REPORT

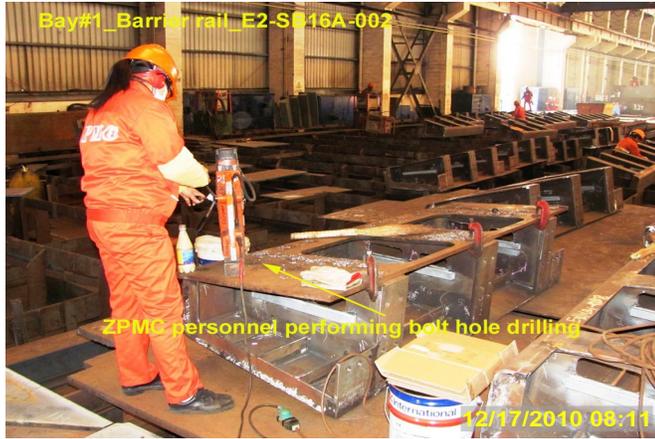
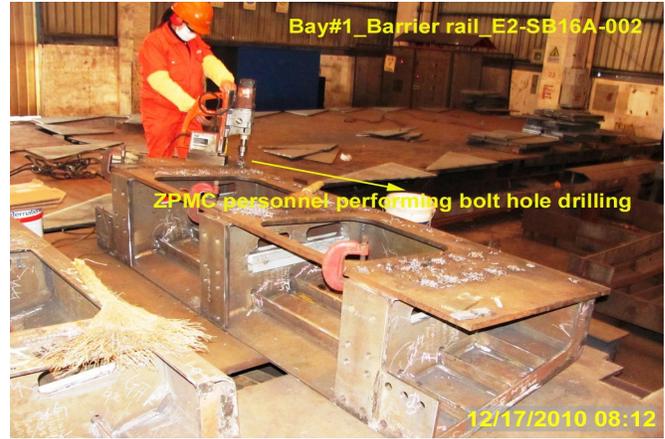
ZPMC personnel performing bolt hole drilling for the steel barrier rail identified as E2-SB16A-002. Refer the attached photos for reference.
