DEPARTMENT OF TRANSPORTATION

Quality Assurance and Source Inspection

Contract #: 04-0120F4Cty: SF/ALA Rte: 80 PM: 13.2/13.9File #: 69.28**WELDING INSPECTION REPORT****Resident Engineer:** Siegenthaler, Peter**Address:** 333 Burma Road**City:** Oakland, CA 94607**Report No:** WIR-018866**Date Inspected:** 27-Dec-2010**Project Name:** SAS Superstructure**OSM Arrival Time:** 700**Prime Contractor:** American Bridge/Fluor Enterprises, a JV**OSM Departure Time:** 1900**Contractor:** Zhenhua Port Machinery Company, Ltd (ZPMC), Changxing Island **Location:** Shanghai, China**CWI Name:** Liu Hua Jie**CWI Present:** Yes No**Inspected CWI report:** Yes No N/A**Rod Oven in Use:** Yes No N/A**Electrode to specification:** Yes No N/A**Weld Procedures Followed:** Yes No N/A**Qualified Welders:** Yes No N/A**Verified Joint Fit-up:** Yes No N/A**Approved Drawings:** Yes No N/A**Approved WPS:** Yes No N/A**Delayed / Cancelled:** Yes No N/A**Bridge No:** 34-0006**Component:** OBG COMPONENT**Summary of Items Observed:**

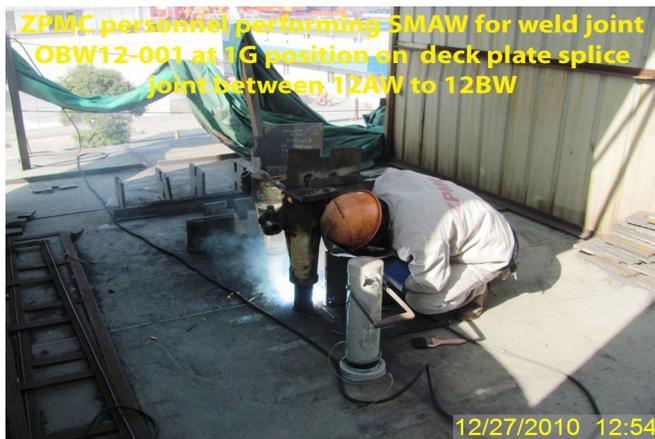
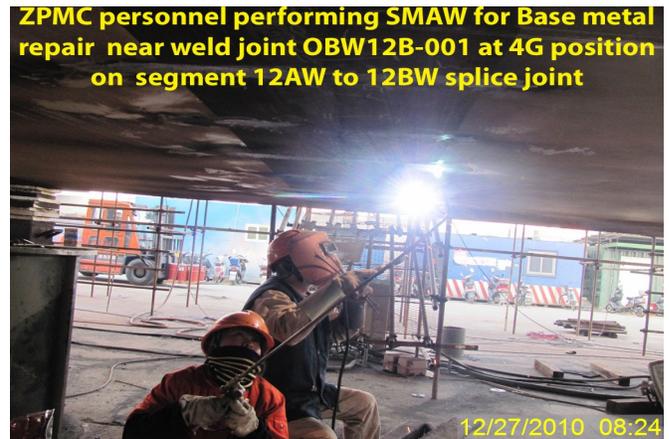
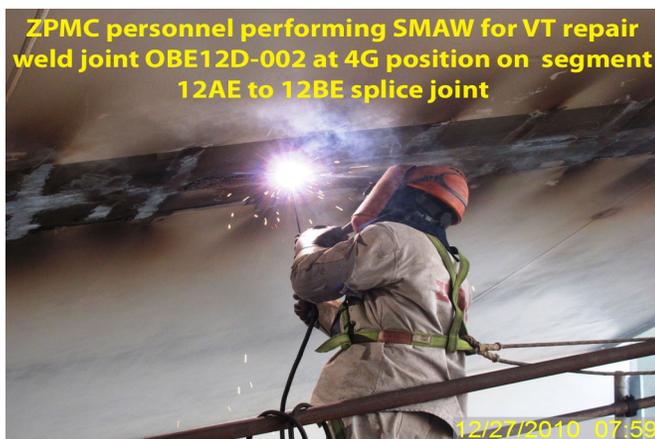
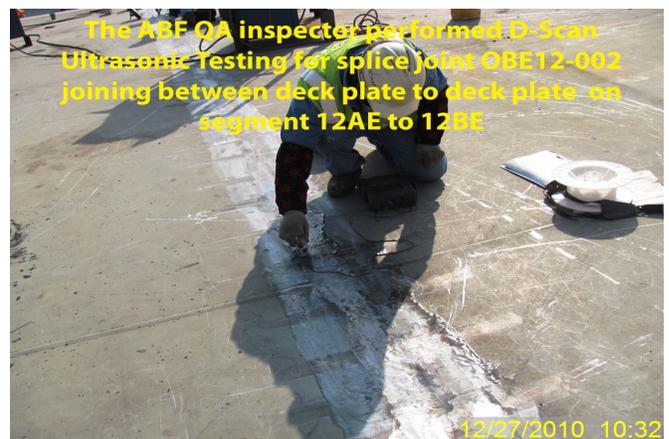
SMAW in the 4G position for the OBG Segment 12AE to 12BE for VT repair weld No.OBE12D-002. The welder is identified as #050289. ZPMC QC is identified as Mr. An Qing Xing. The welding variables recorded by QC appear to comply with WPS-345-SMAW-4G(4F)-FCM-REPAIR-1. The repair report is identified as WR17903.

SMAW in the 4G position for the OBG Segment 12AW to 12BW base metal repair near weld No.OBW12B-001. The welder is identified as #040611. ZPMC QC is identified as Mr. Zhou Peng. The welding variables recorded by QC appear to comply with WPS-345-SMAW-4G(4F)-FCM-REPAIR-1. The repair report is identified as CWR2126.

SMAW in the 1G position for the OBG Segment 12AW to 12BW weld No.OBW12-001. The welder is identified as #044551. ZPMC QC is identified as Mr. Zhou Peng. The welding variables recorded by QC appear to comply with WPS-B-P-2211-B-U2-FCM-1.

SMAW in the 4F position for the OBG Segment 12AW weld No.DP3049-001-031/032. The welder is identified as #057333. ZPMC QC is identified as Mr. Zhou Peng. The welding variables recorded by QC appear to comply with WPS-B-T-2114-1.

SMAW in the 4F position for the OBG Segment 12AW weld No.DP3060-001-007/008. The welder is identified as #057333. ZPMC QC is identified as Mr. Zhou Peng. The welding variables recorded by QC appear to comply with WPS-B-T-2114-1.

SMAW in the 2G position for the OBG Segment 12AE for VT repair weld No.CA3002-002. The welder is identified as #044515. ZPMC QC is identified as Mr. An Qing Xing. The welding variables recorded by QC appear to comply with WPS-345-SMAW-2G(2F)-FCM-REPAIR-1.
