**DEPARTMENT OF TRANSPORTATION**

Quality Assurance and Source Inspection

Contract #: 04-0120F4Cty: SF/Ala Rte: 80 PM: 13.2/13.9File #: 69.28**WELDING INSPECTION REPORT****Resident Engineer:** Siegenthaler, Peter**Address:** 333 Burma Road**City:** Oakland, CA 94607**Report No:** WIR-018893**Date Inspected:** 20-Dec-2010**Project Name:** SAS Superstructure**OSM Arrival Time:** 1900**Prime Contractor:** American Bridge/Fluor Enterprises, a JV**OSM Departure Time:** 700**Contractor:** Zhenhua Port Machinery Company, Ltd (ZPMC), Changxing Island **Location:** Shanghai, China**CWI Name:** See below**CWI Present:** Yes No**Inspected CWI report:** Yes No N/A**Rod Oven in Use:** Yes No N/A**Electrode to specification:** Yes No N/A**Weld Procedures Followed:** Yes No N/A**Qualified Welders:** Yes No N/A**Verified Joint Fit-up:** Yes No N/A**Approved Drawings:** Yes No N/A**Approved WPS:** Yes No N/A**Delayed / Cancelled:** Yes No N/A**Bridge No:** 34-0006**Component:** OBG and Tower Components**Summary of Items Observed:**

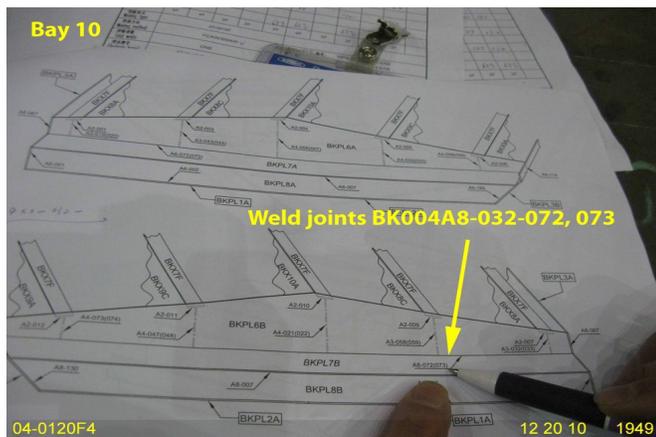
SMAW tack welding of weld joints BK004A8-032-072, 073 located on PCMK OBG BK004-032, stiffener end plate to bearing plate. Welders were identified as 057239, 040400. QC was identified as QC1. Assisting QC1 at this location and appearing to be monitoring the welding operation and recording data was QCA1, who was not a CWI. Weld variables recorded by QCA1 appeared to comply with WPS-B-P-2112 as verbally identified by QCA1.

See photo of the drawing presented to this QA Inspector by QCA1 showing the welds noted above.
