Contract #: 04-0120F4Cty: SF/ALA Rte: 80 PM: 13.2/13.9File #: 69.28**WELDING INSPECTION REPORT****Resident Engineer:** Siegenthaler, Peter**Address:** 333 Burma Road**City:** Oakland, CA 94607**Report No:** WIR-018931**Date Inspected:** 16-Dec-2010**Project Name:** SAS Superstructure**OSM Arrival Time:** 700**Prime Contractor:** American Bridge/Fluor Enterprises, a JV**OSM Departure Time:** 1900**Contractor:** Zhenhua Port Machinery Company, Ltd (ZPMC), Changxing Island **Location:** Shanghai, China**CWI Name:** Xu Xian Ping**CWI Present:** Yes No**Inspected CWI report:** Yes No N/A**Rod Oven in Use:** Yes No N/A**Electrode to specification:** Yes No N/A**Weld Procedures Followed:** Yes No N/A**Qualified Welders:** Yes No N/A**Verified Joint Fit-up:** Yes No N/A**Approved Drawings:** Yes No N/A**Approved WPS:** Yes No N/A**Delayed / Cancelled:** Yes No N/A**Bridge No:** 34-0006**Component:** Orthotropic Box Girder (OBG)**Summary of Items Observed:**

OBG # CROSSBEAM CB18

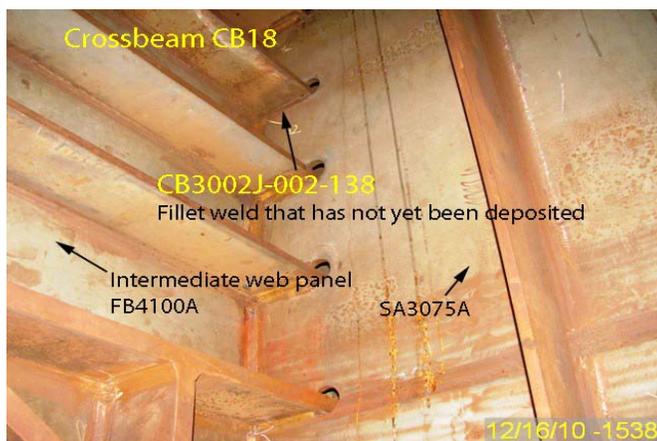
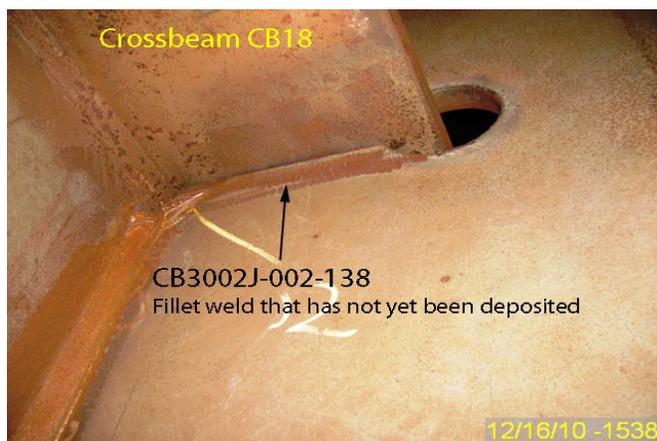
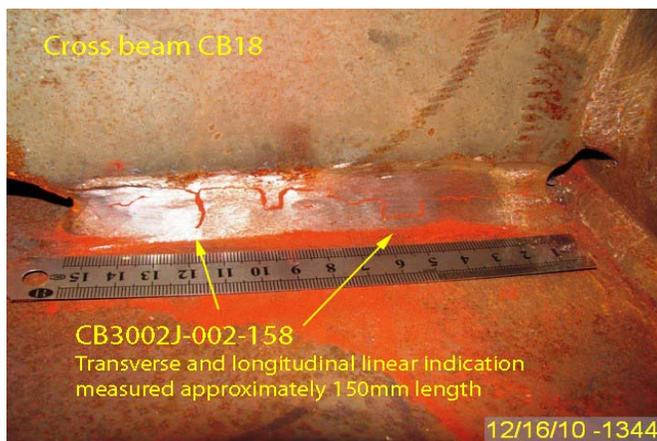
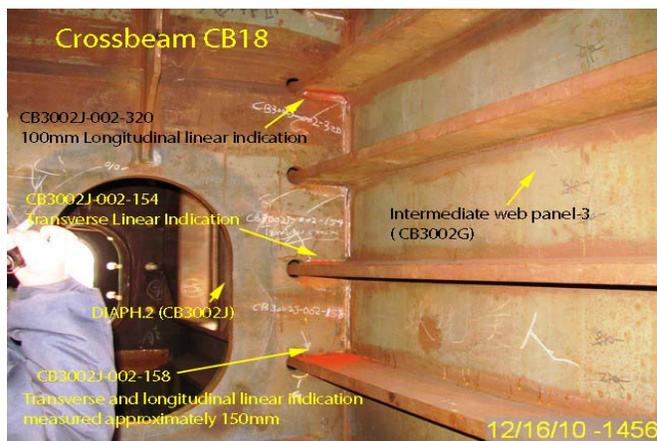
This QA inspector received ZPMC Non Destructive Testing (NDT) notification 07782 to perform Magnetic particle Testing (MT) of approximately 15% of the area previously tested and accepted by ZPMC Quality Control Personnel. This QA Inspector generated a Magnetic particle Test report for this date. The member is identified as Crossbeam CB18. The weld tested is identified as follows:

- (CB3002J-002-158) Non compliant Indication
- (CB3002J-002-154) Non compliant Indication
- (CB3002J-002-320) Non compliant Indication
- (CB3002K-003-029) Non compliant Indication
- (CB3002K-004-158) Non compliant Indication

ZPMC Quality Control (QC) inspectors have issued a report stating that they had visually tested and accepted a

fillet weld where the fillet appears to be missing. VT report identified as B-VT-87758, documents that this weld was visually tested and accepted. The weld is identified as CB3002J-002-138.

This weld is a fillet weld joining Floor Beam (FB4100A) to the I-rib stiffeners (X3726E) and the interior Diaphragm identified as SA3075A. The notice of witness Inspection Number (NWIT) is 07782. This weld joint is within an area that has been previously tested and accepted by ZPMC Quality Control (QC) personal. As per contract documents ZPMC is required to perform 100% visual testing (VT) of this weld. This QA notified ZPMC Certified Welding Inspector (CWI) identified as Mr. Huang ming of this issue and that an incident report would be generated. See attached pictures.

This QA notified ZPMC Certified Welding Inspector (CWI) identified as Mr. Huang ming of this issue and that an incident report would be generated. For more information please refer generated incident report on this date. See attached pictures.
