**DEPARTMENT OF TRANSPORTATION**

Contract #: 04-0120F4Cty: SF/ALA Rte: 80 PM: 13.2/13.9File #: 69.28**WELDING INSPECTION REPORT****Resident Engineer:** Siegenthaler, Peter**Address:** 333 Burma Road**City:** Oakland, CA 94607**Report No:** WIR-018983**Date Inspected:** 27-Dec-2010**Project Name:** SAS Superstructure**OSM Arrival Time:** 700**Prime Contractor:** American Bridge/Fluor Enterprises, a JV**OSM Departure Time:** 1900**Contractor:** Zhenhua Port Machinery Company, Ltd (ZPMC), Changxing Island **Location:** Shanghai, China**CWI Name:** Mr. Liu Fa Wen**CWI Present:** Yes No**Inspected CWI report:** Yes No N/A**Rod Oven in Use:** Yes No N/A**Electrode to specification:** Yes No N/A**Weld Procedures Followed:** Yes No N/A**Qualified Welders:** Yes No N/A**Verified Joint Fit-up:** Yes No N/A**Approved Drawings:** Yes No N/A**Approved WPS:** Yes No N/A**Delayed / Cancelled:** Yes No N/A**Bridge No:** 34-0006**Component:** OBG/Tower**Summary of Items Observed:**

## WELDING INSPECTION REPORT

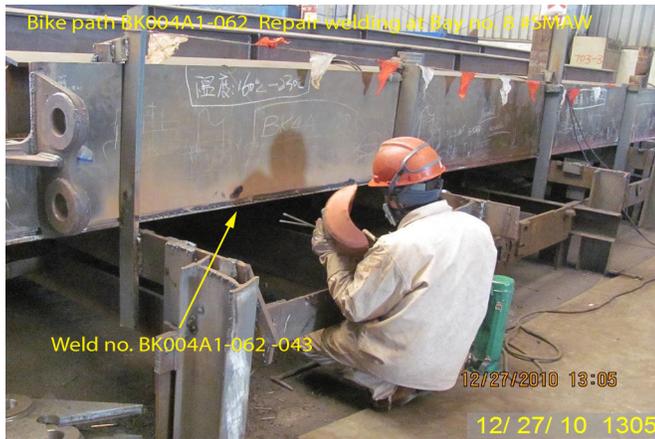
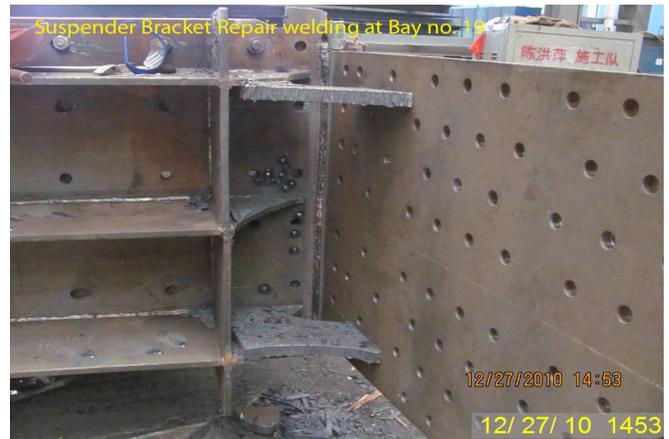
For further information see below pictures:-

Unless otherwise noted, all work observed on this date appeared to be in general compliance with the applicable contract documents.
