DEPARTMENT OF TRANSPORTATION

Contract #: 04-0120F4Cty: SF/ALA Rte: 80 PM: 13.2/13.9File #: 69.28**WELDING INSPECTION REPORT****Resident Engineer:** Siegenthaler, Peter**Address:** 333 Burma Road**City:** Oakland, CA 94607**Report No:** WIR-019008**Date Inspected:** 29-Dec-2010**Project Name:** SAS Superstructure**OSM Arrival Time:** 700**Prime Contractor:** American Bridge/Fluor Enterprises, a JV**OSM Departure Time:** 1900**Contractor:** Zhenhua Port Machinery Company, Ltd (ZPMC), Changxing Island **Location:** Shanghai, China**CWI Name:** Liu Hua Jie**CWI Present:** Yes No**Inspected CWI report:** Yes No N/A**Rod Oven in Use:** Yes No N/A**Electrode to specification:** Yes No N/A**Weld Procedures Followed:** Yes No N/A**Qualified Welders:** Yes No N/A**Verified Joint Fit-up:** Yes No N/A**Approved Drawings:** Yes No N/A**Approved WPS:** Yes No N/A**Delayed / Cancelled:** Yes No N/A**Bridge No:** 34-0006**Component:** OBG COMPONENT**Summary of Items Observed:**

WELDING INSPECTION REPORT

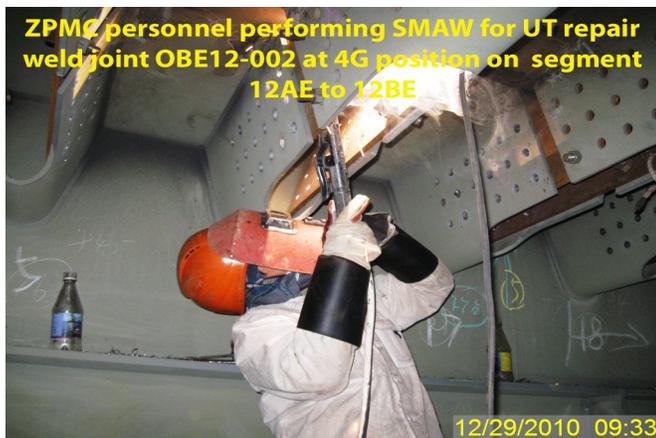
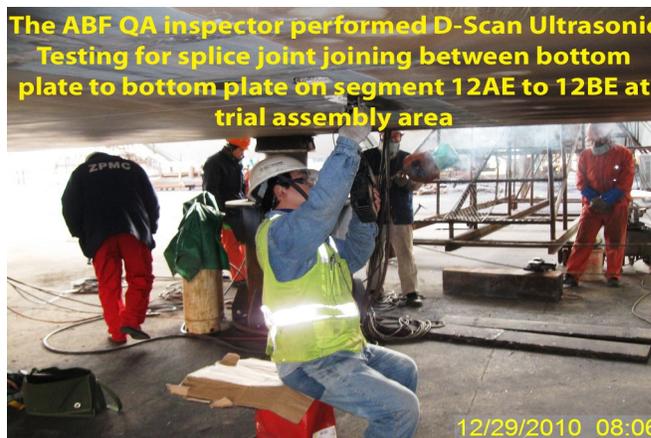
SMAW in the 4G position for the OBG Segment 12AE to 12BE for base metal repair near splice joint of bottom plate to bottom plate, VT repair weld No. OBE12B-001. The welder is identified as #044515. ZPMC QC is identified as Mr. An Qing Xing. The welding variables recorded by QC appear to comply with WPS-345-SMAW-4G(4F)-FCM-REPAIR-1. The repair report is identified as CWR2129.

SMAW in the 1G position for the OBG Segment 12AE to 12BE for splice joint of deck plate to deck plate, UT repair weld No. OBE12-002,003. The welder is identified as #044515. ZPMC QC is identified as Mr. An Qing Xing. The welding variables recorded by QC appear to comply with WPS-345-SMAW-1G(1F)-FCM-REPAIR-1. The repair report is identified as WR19643.

SMAW in the 4G position for the OBG Segment 12AW to 12BW for splice joint of side plate to side plate at cross beam side , VT repair weld No.OBW12-004. The welder is identified as #040611. ZPMC QC is identified as Mr. Zhou Peng. The welding variables recorded by QC appear to comply with WPS-345-SMAW-4G(4F)-FCM-REPAIR-1.

SMAW in the 4G position for the OBG Segment 12AW to 12BW for near splice joint of side plate to side plate at cross beam side , VT repair weld No.OBW12D-001. The welder is identified as #040611. ZPMC QC is identified as Mr. Zhou Peng. The welding variables recorded by QC appear to comply with WPS-345-SMAW-4G(4F)-FCM-REPAIR-1.

This QA Inspector performed Ultrasonic testing (UT) verification of the area previously tested and accepted by ABF Quality control personnel. This QA inspector generated a (UT) report for this date. The member is identified as butt joint joining between side Plate to bottom Plate for OBG segment 12AW at counter weight side . The result was recorded onto a data sheet according to rejection criteria of "D" Scan procedure 001 rev.1 that Caltrans QA and ABF QA have jointly filled out on this date. The QA inspector found no rejectable indication at scanned area.
