Quality Assurance and Source Inspection

Contract #: 04-0120F4Cty: SF/ALA Rte: 80 PM: 13.2/13.9File #: 69.28**WELDING INSPECTION REPORT****Resident Engineer:** Siegenthaler, Peter**Address:** 333 Burma Road**City:** Oakland, CA 94607**Report No:** WIR-019026**Date Inspected:** 21-Dec-2010**Project Name:** SAS Superstructure**OSM Arrival Time:** 700**Prime Contractor:** American Bridge/Fluor Enterprises, a JV**OSM Departure Time:** 1900**Contractor:** Zhenhua Port Machinery Company, Ltd (ZPMC), Changxing Island **Location:** Shanghai, China**CWI Name:** Lv Li Qing**CWI Present:** Yes No**Inspected CWI report:** Yes No N/A**Rod Oven in Use:** Yes No N/A**Electrode to specification:** Yes No N/A**Weld Procedures Followed:** Yes No N/A**Qualified Welders:** Yes No N/A**Verified Joint Fit-up:** Yes No N/A**Approved Drawings:** Yes No N/A**Approved WPS:** Yes No N/A**Delayed / Cancelled:** Yes No N/A**Bridge No:** 34-0006**Component:** OBG**Summary of Items Observed:**

OBG 13EAST

OBG 14 EAST

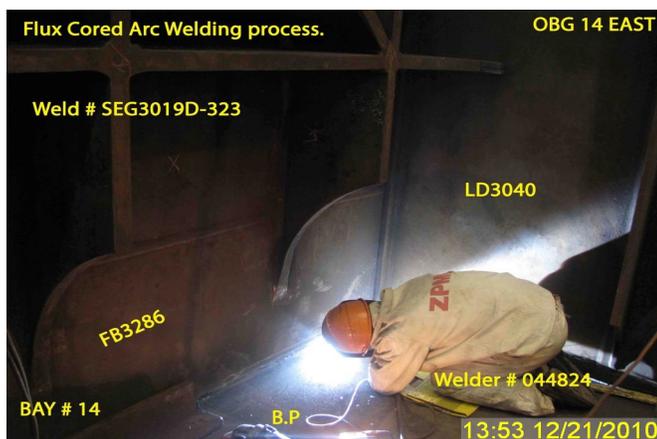
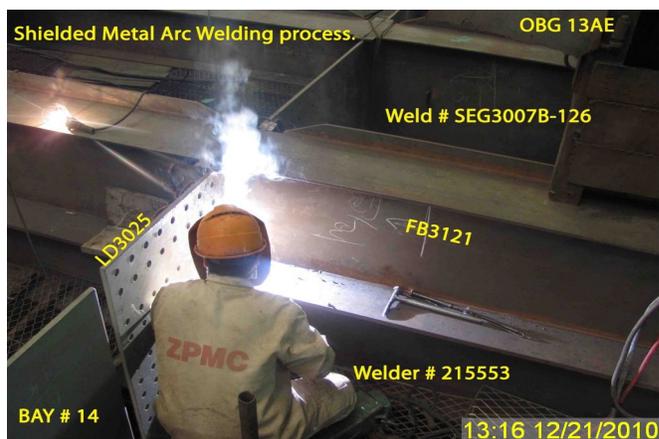
This Quality Assurance (QA) Inspector observed ZPMC qualified welder 067571 performing the Shielded Metal Arc Welding process on weld 008 located at PCMK FB3110-001. ZPMC QC Mr. Lv Li Qing was monitoring this welding operation. The welding variables recorded by QC appeared to comply with WPS-345-SMAW-4G (4F)-Fcm-Repair-1. Weld Repair report identified as B-WR18309.

This Quality Assurance (QA) Inspector observed ZPMC qualified welder 044824 performing the Flux Cored Arc Welding process on weld 323 located at PCMK SEG3019D. ZPMC QC Mr. Zhong Guo Hui was monitoring this welding operation. The welding variables recorded by QC appeared to comply with WPS-B-T-2232-ESAB.
